### ADSS Parking Survey

Meridian Community Primary School, Roderick Avenue,  
Peacehaven, East Sussex

Parking Survey 3<sup>rd</sup> July 2015

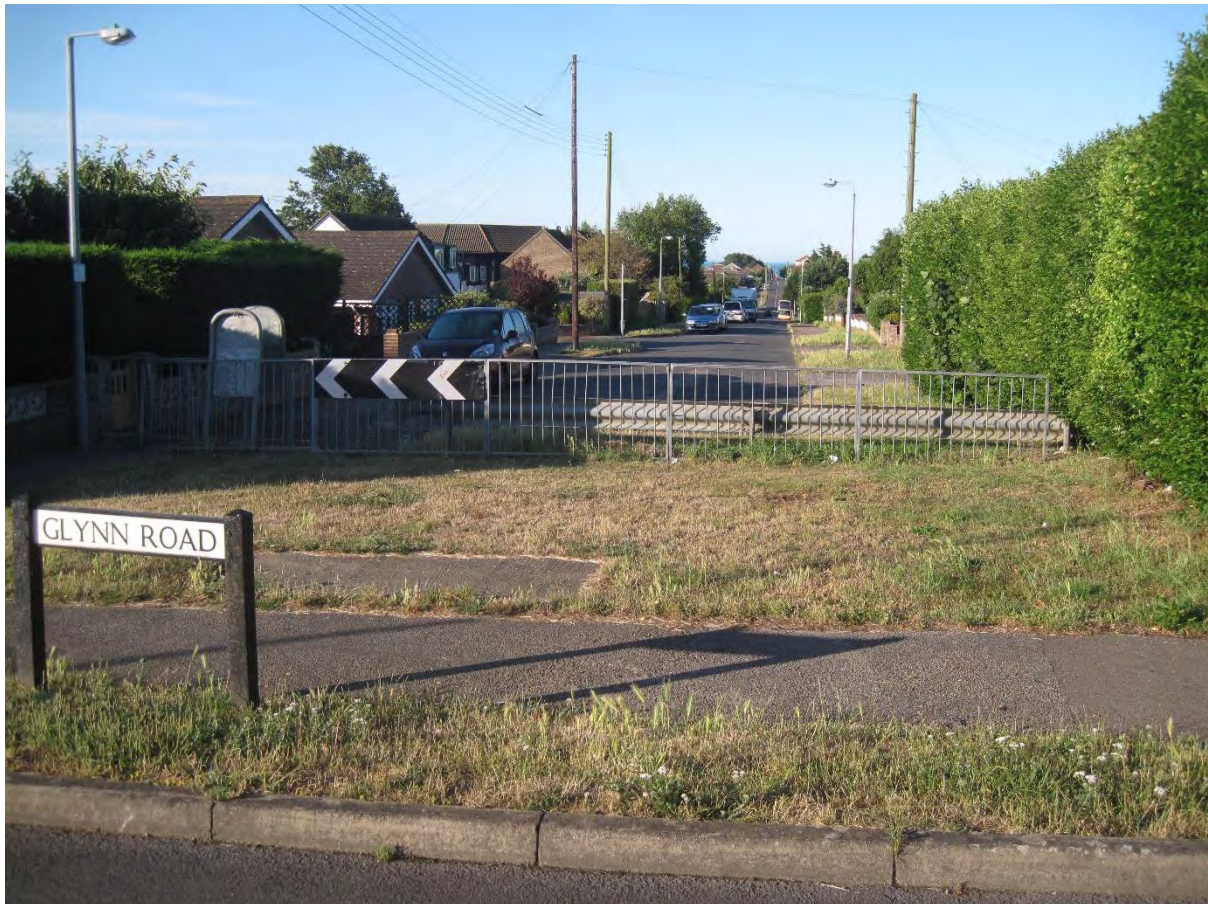
The southern section is a cul-de-sac terminating at its junction with Glynn Road. Roderick Road to the south of its junction with Pelham Rise forms one of the main local distributors down to the A259 coast road. There were a number of vehicles parked throughout the survey period, but the overall number doubled at peak times up to about its practical capacity. The level of parking did not appear to impede access.

The southern section of Roderick Avenue looking south from Glynn Road

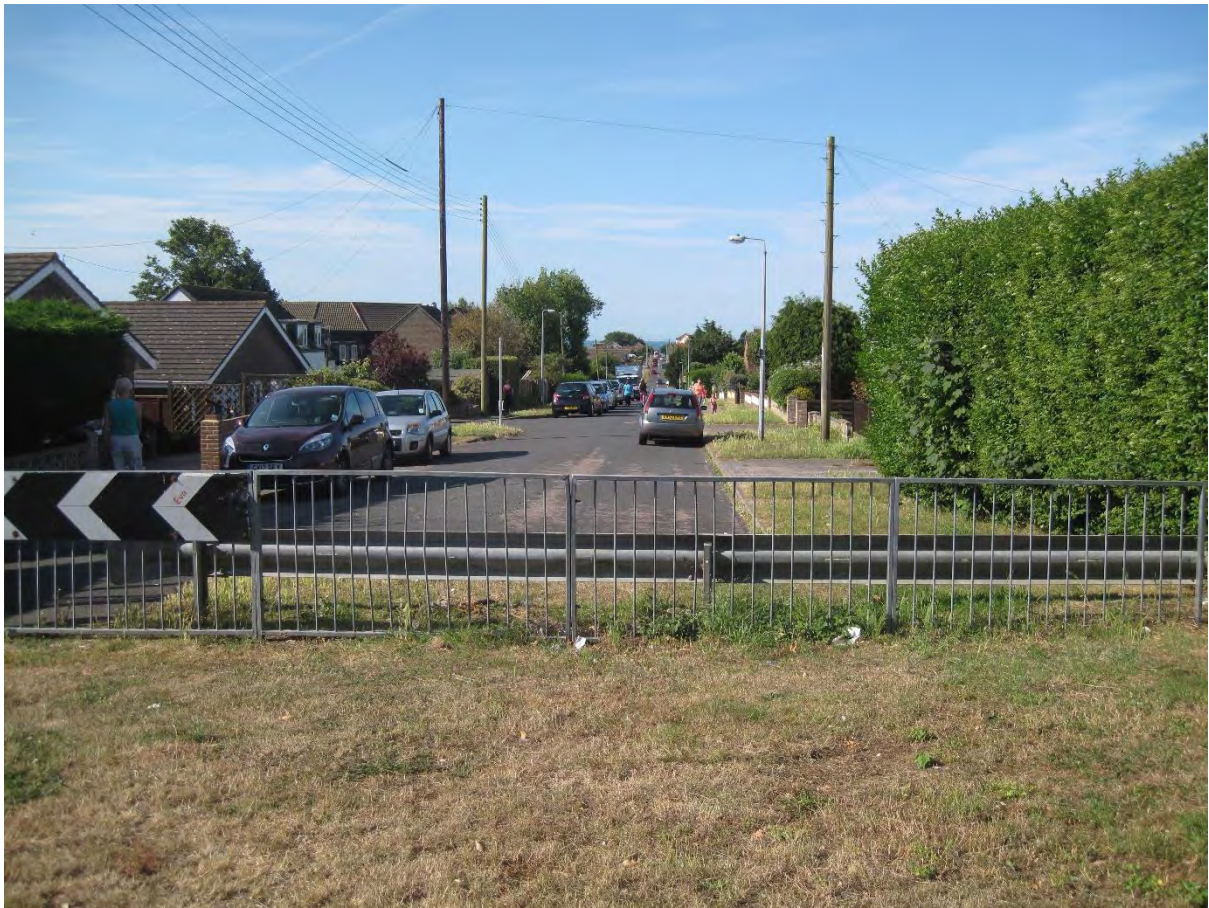
The southern section of Roderick Avenue at close to practical parking capacity during the morning peak

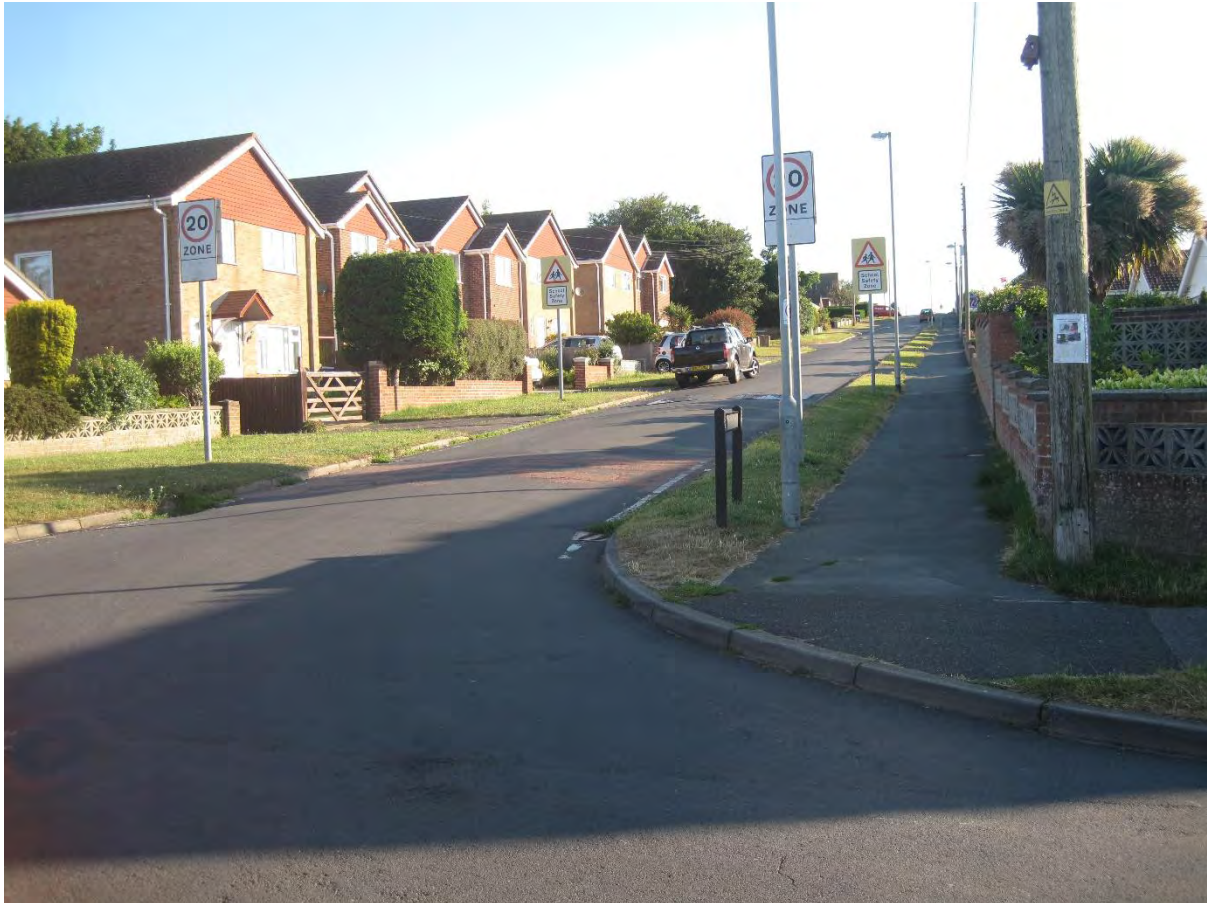
North of Glynn Road, the section of Roderick Avenue which contains the main school access, is a traffic-calmed 20 mph school safety zone. This section had little parking outside the periods of peak school activity. During the peak periods, the level of parking substantially increased reaching a maximum of about 80% of practical capacity in the morning peak concentrated around the school entrance. Parking was not observed to take place on the School Keep Clear markings and access appeared to be reasonably trouble-free at all times. Parking was biased toward the southern end of this section and school related parking was not observed to extend as far north as Mount Caburn Crescent at any time.

Roderick Avenue looking north from Glynn Road

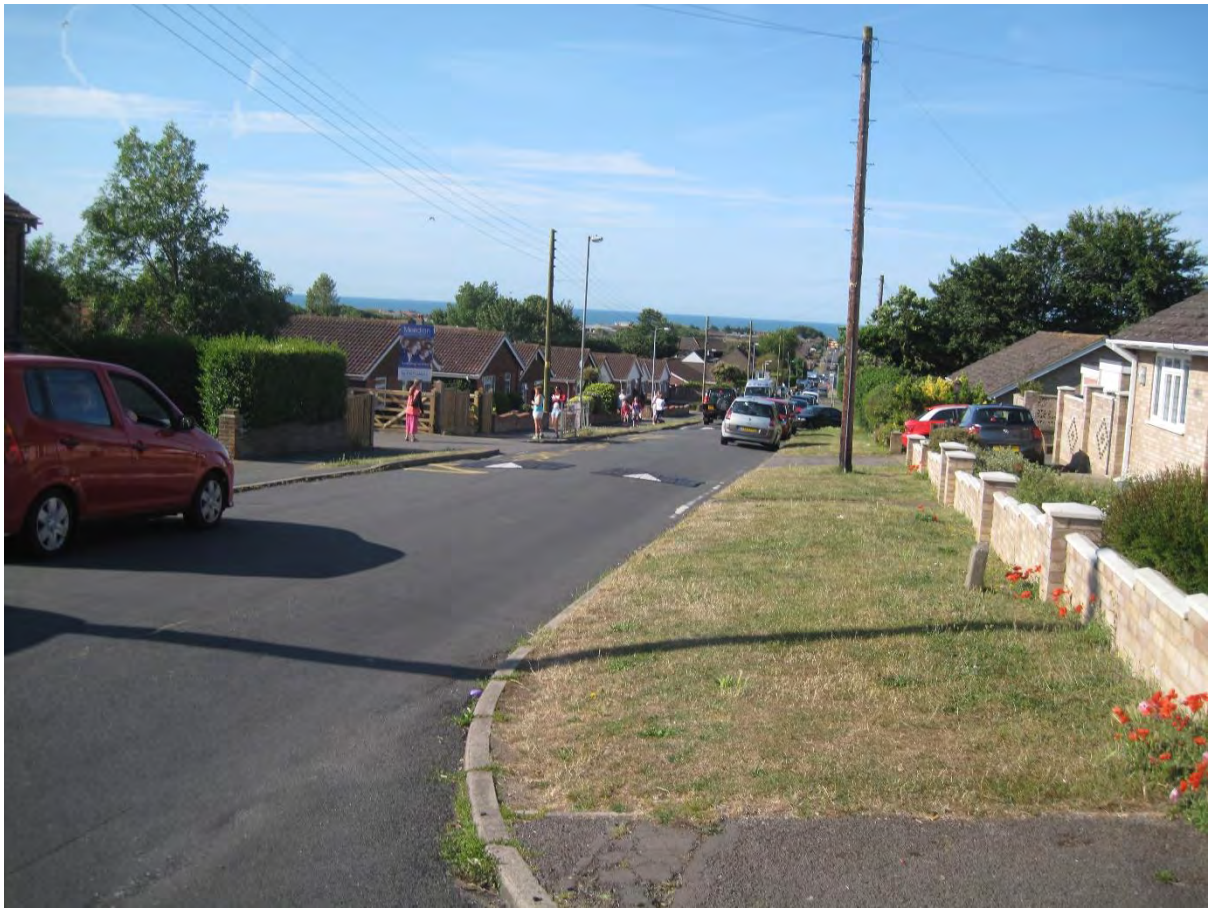
Roderick Ave looking south from Tor Rd past the school entrance at the height of the morning peak

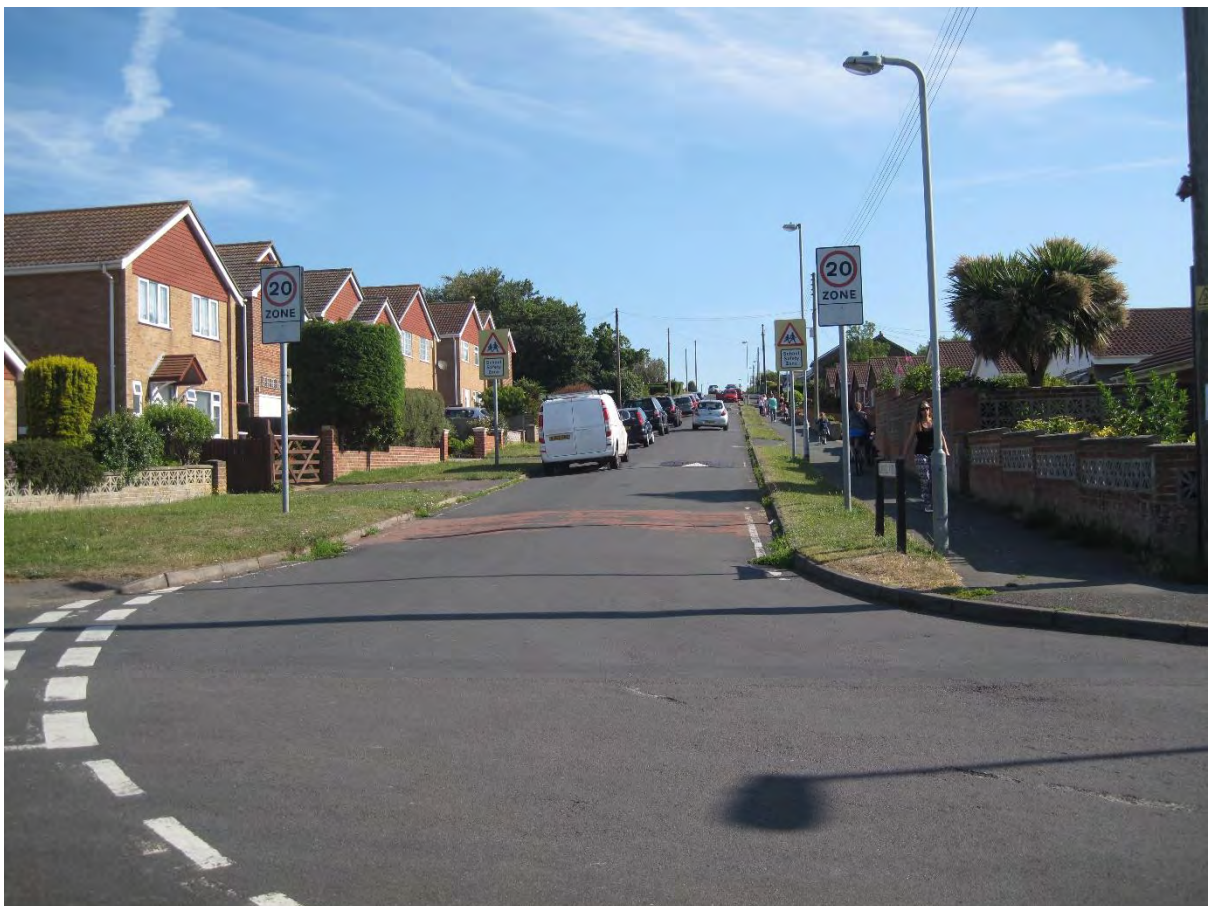
Roderick Ave looking north from Glynn Road during the morning peak

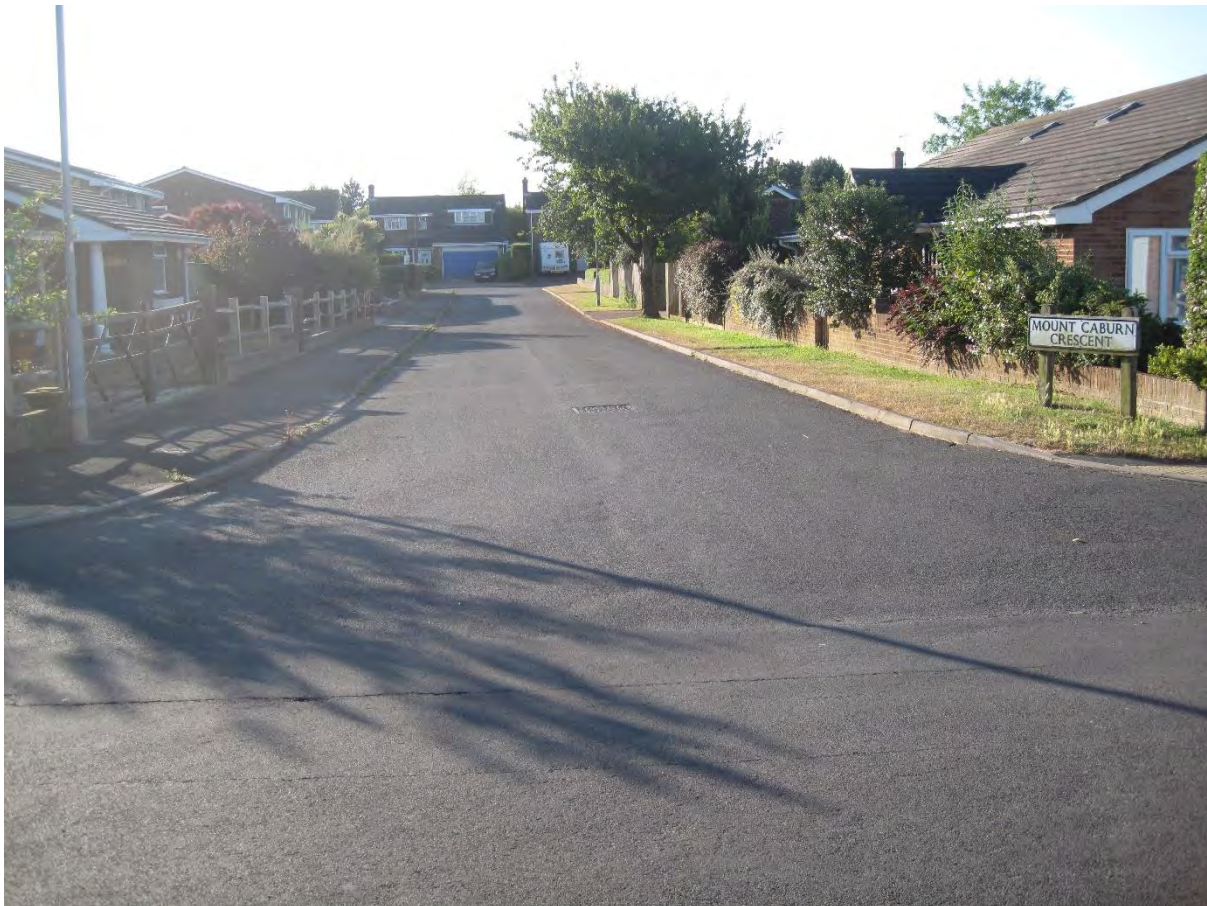
Mount Caburn Crescent is a cul-de-sac on the eastern side of Roderick Avenue and was very quiet throughout the survey periods with little, if any, school related parking despite being within a short walk of the school entrance. The vehicles recorded were nearly all in the north and south arms at the eastern end of the cul-de-sac where there are the majority of residential accesses.

Mount Caburn Crescent looking east from Roderick Avenue

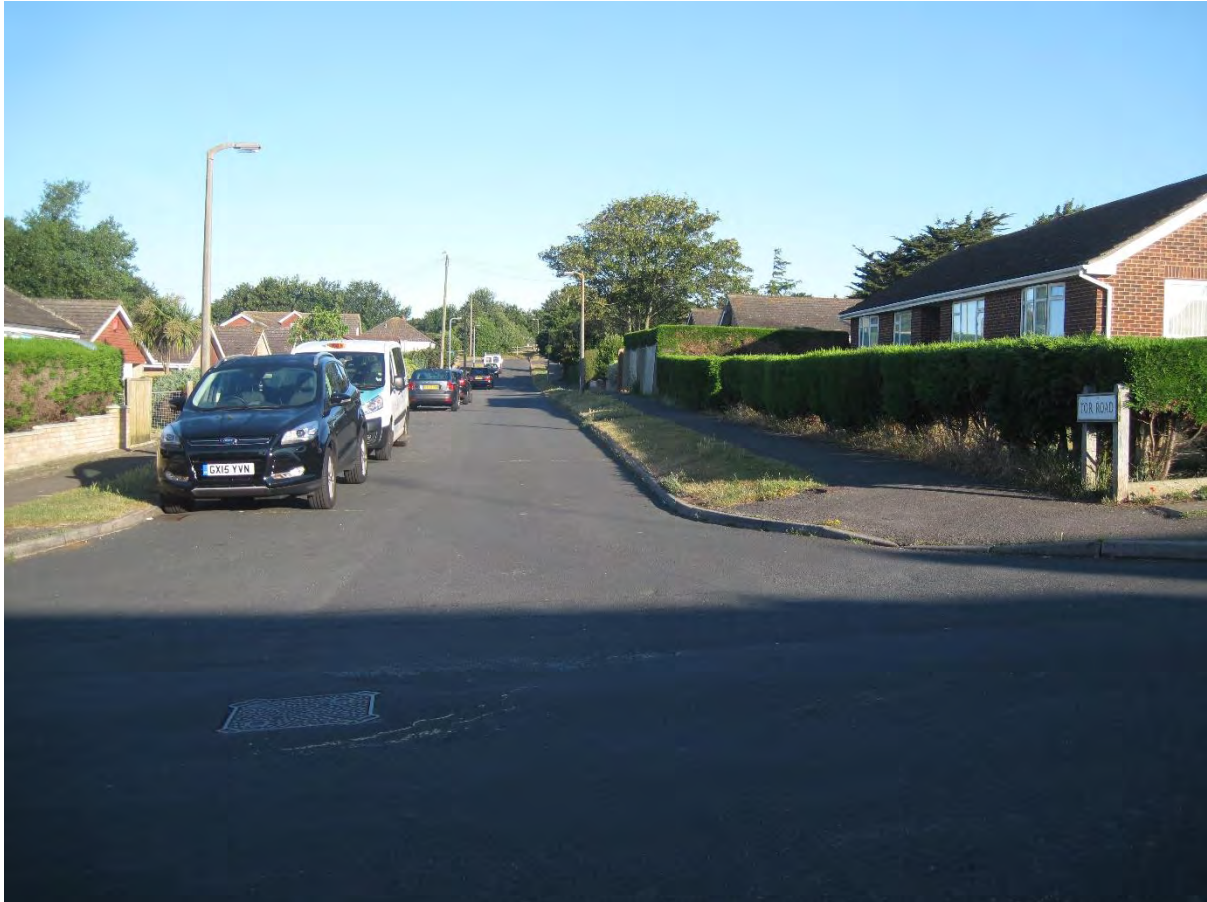
Tor Road is a cul-de-sac to the west of Roderick Avenue whose junction is just to the north of the school entrance. This road was one of the more attractive roads for school related parking and was at or close to its practical capacity during the peak periods. Parking was biased toward the Roderick Road end with cars being parked around the junction corners, which, to an extent, impeded access and visibility, but did not appear to cause anything other than momentary congestion at this point.

Tor Road looking east from Roderick Avenue

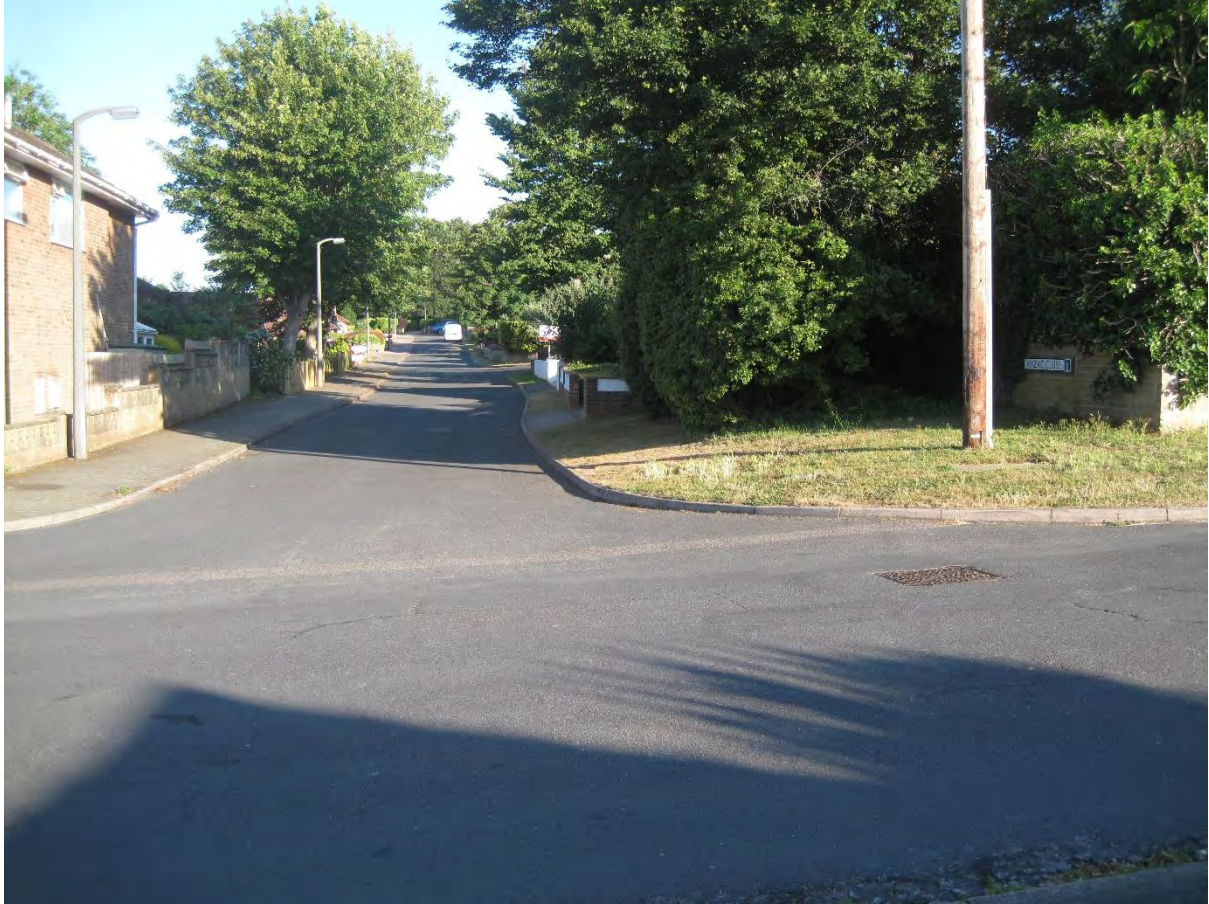
Anzac Close is a cul-de-sac to the west of Roderick Avenue whose junction is just to the south of the school entrance. This road was one of the more attractive roads for school related parking and was at or close to its practical capacity during the peak periods. Parking was biased toward the Roderick Road end with cars being parked around the junction corners, which, to an extent, impeded access and visibility, but did not appear to cause anything other than momentary congestion at this point

Anzac Close looking west from Roderick Avenue.

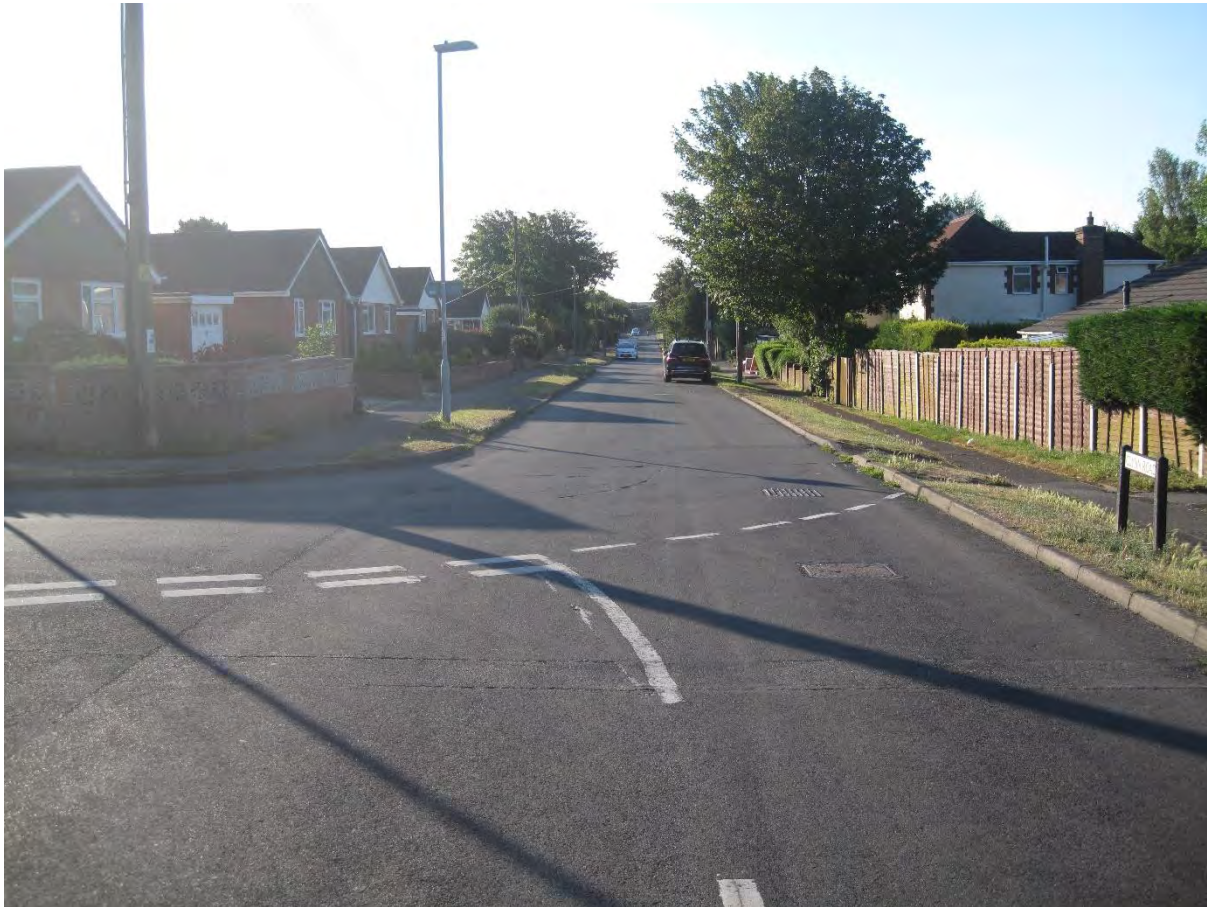
Glynn Road, despite being relatively close to the school, appeared to experience little school related parking. Those vehicles observed parked nearby all seemed to be associated with adjacent properties.

Glynn Road looking east from the junction of Roderick Avenue

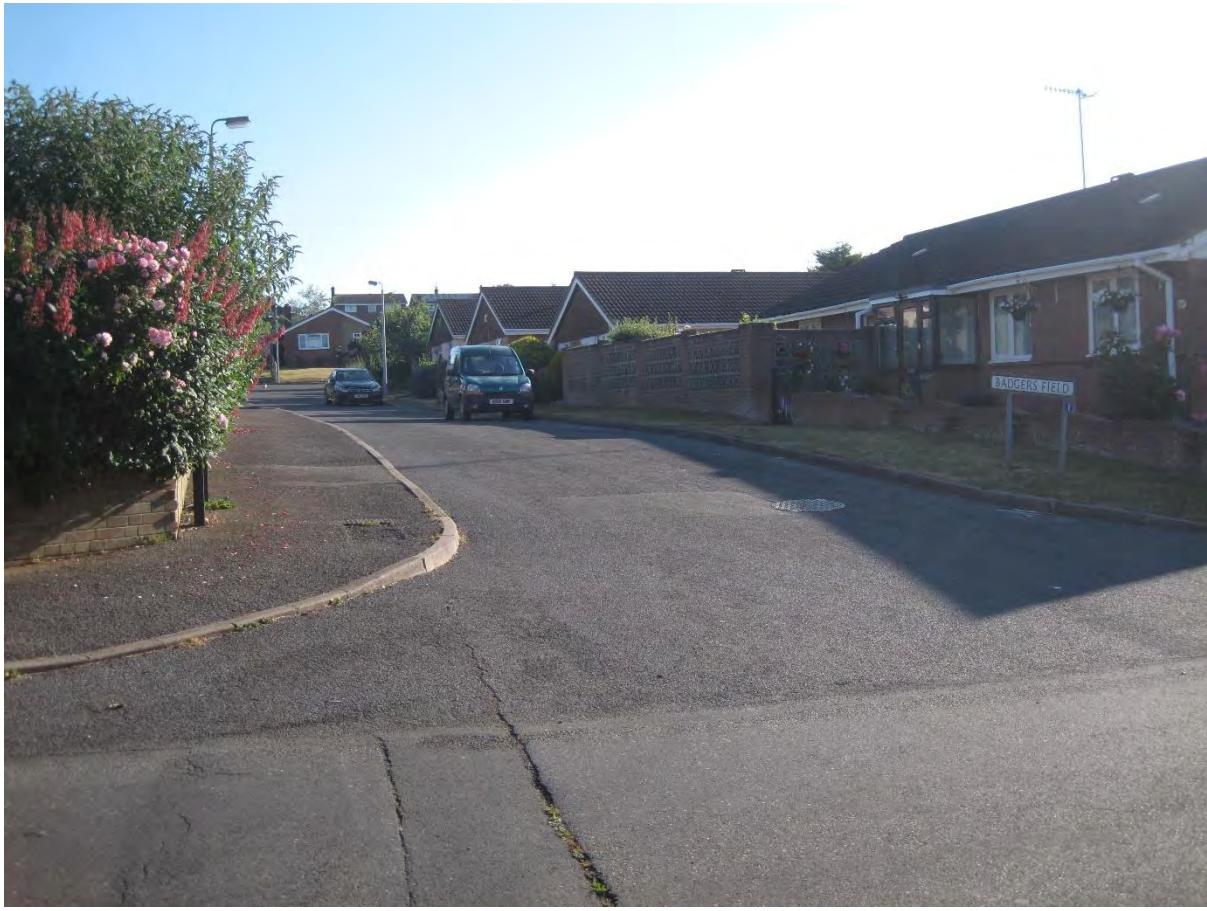
Badgers Field, a cul-de-sac off of Glynn Road had little activity during the survey period and appeared to experience no school related parking.

Badgers Field looking north from Glynn Road

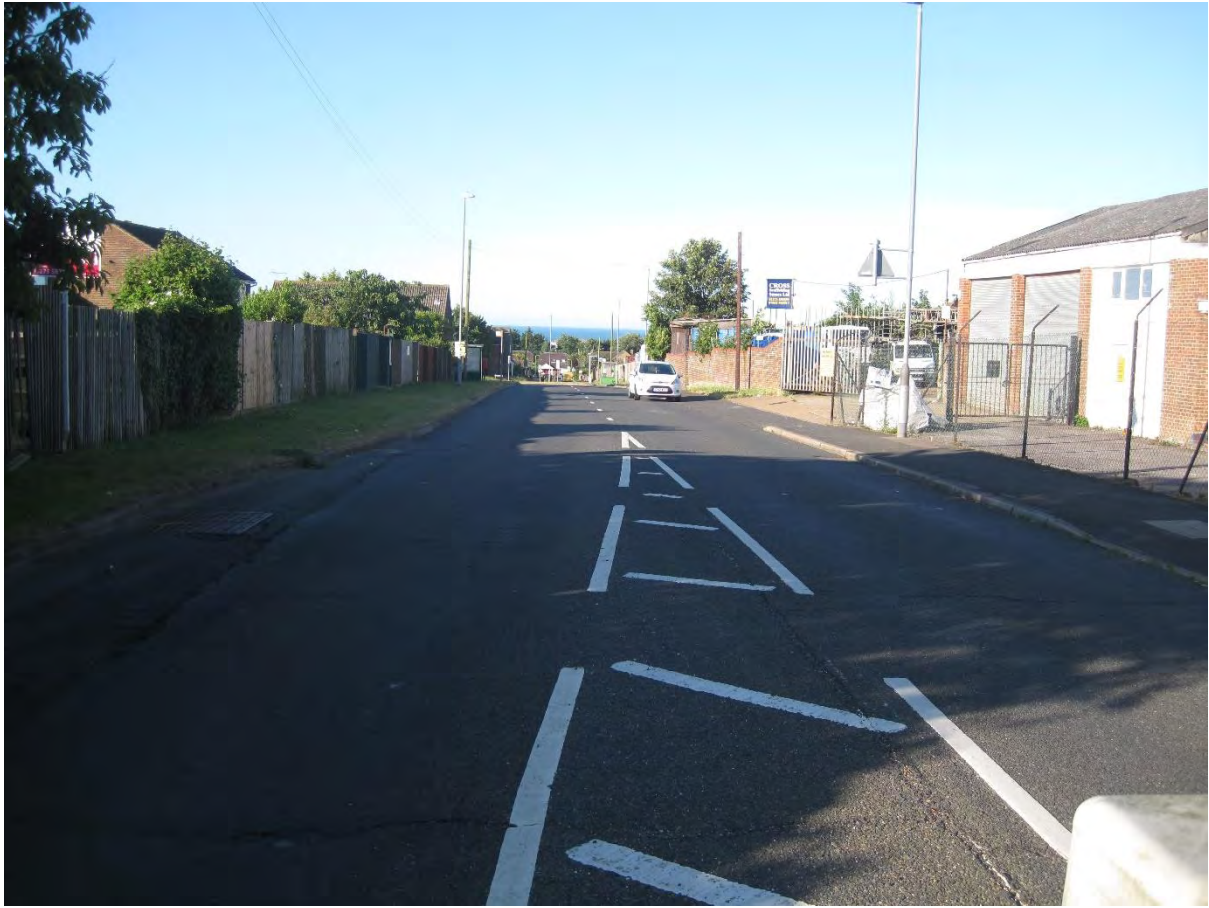
Pelham Rise, as described above, is the main local distributor, connecting with Roderick Avenue and thence the A259 coast road. The overall level of parking observed as a proportion of the practical parking capacity was quite low at all times. School related parking was confined to the immediate vicinity of Cripps Avenue junction, with just a few vehicles being parked to the south of it and up to 6 or 7 vehicles to the north of it on the western side during the peak periods. They did not appear to impede access along Pelham Rise.

Pelham Rise looking south towards Cripps Avenue

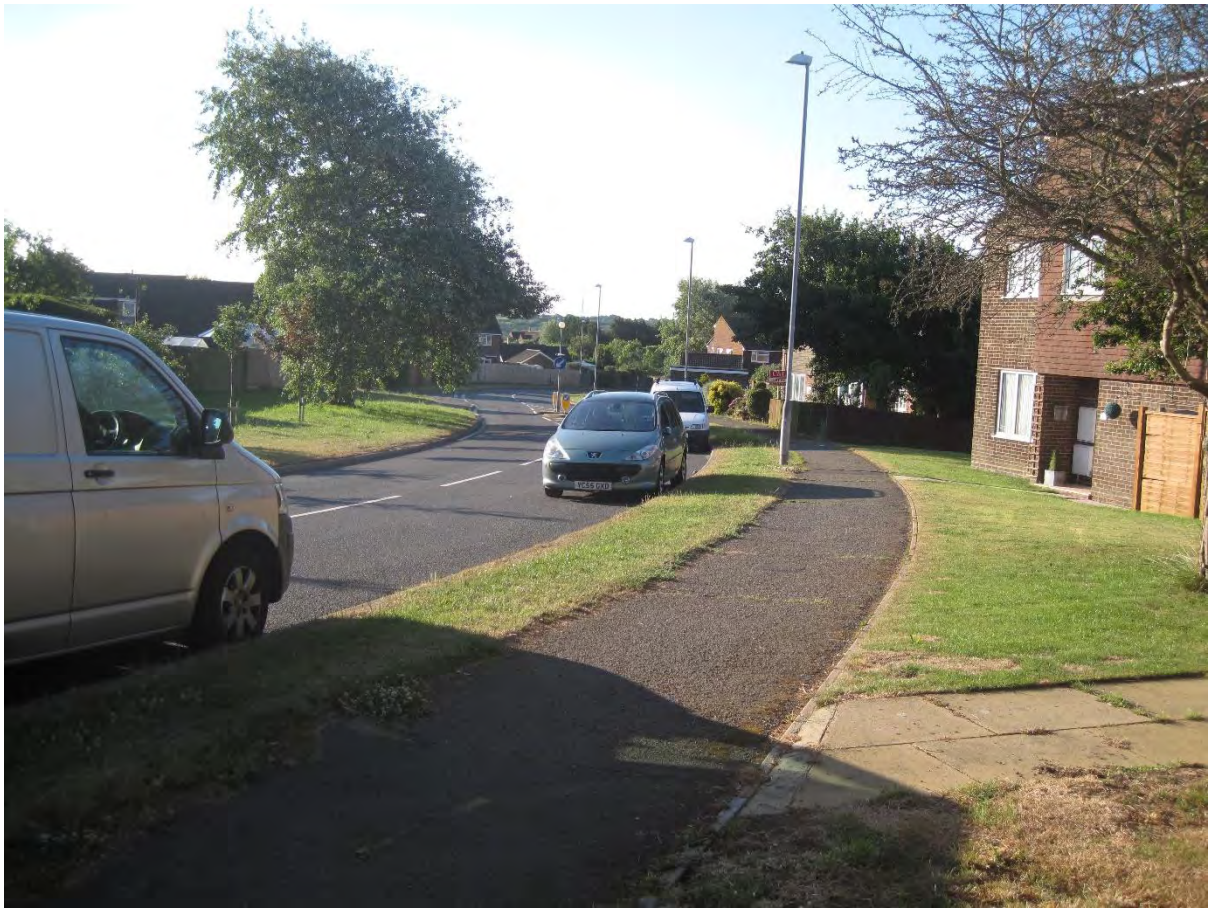
Pelham Rise looking east from Cripps Avenue

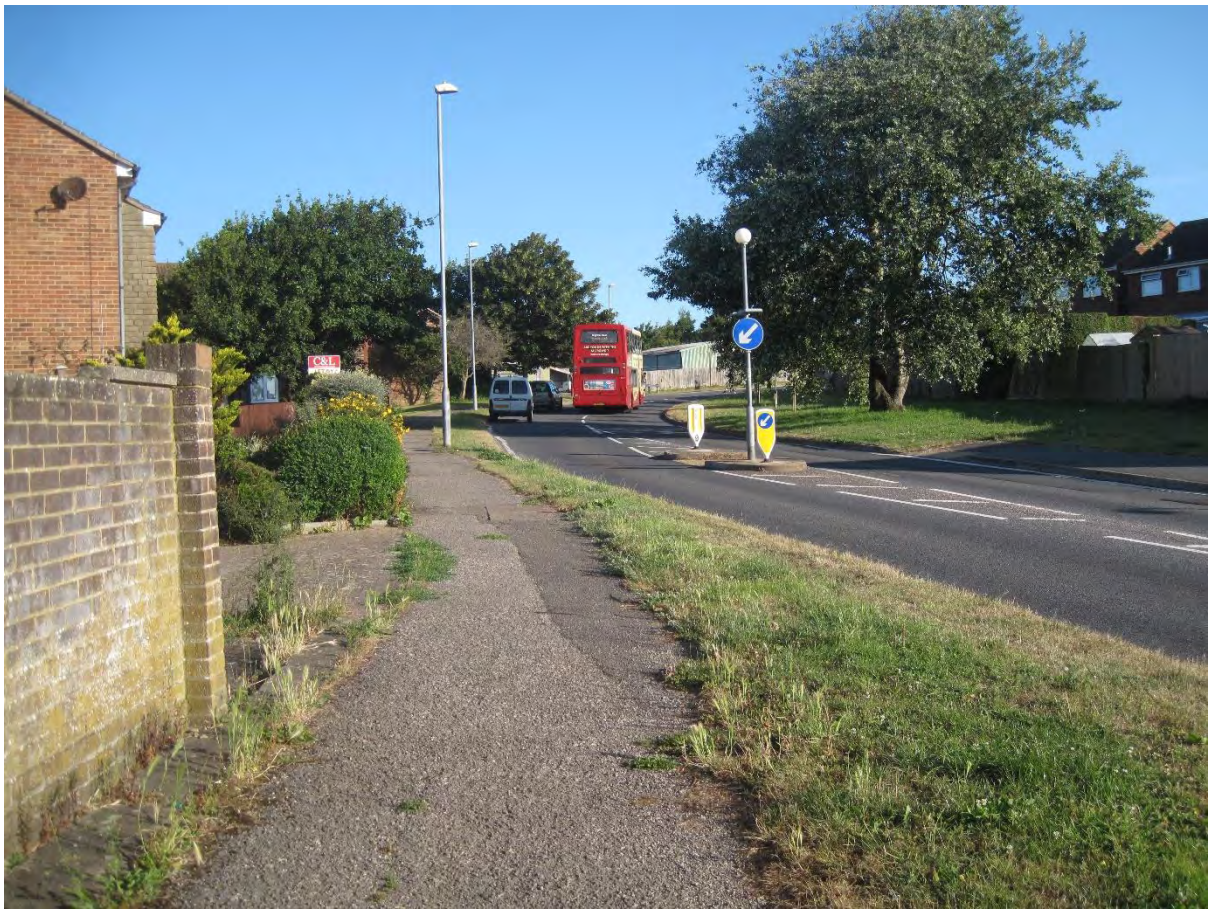
Pelham Rise looking northwest toward Cripps Avenue

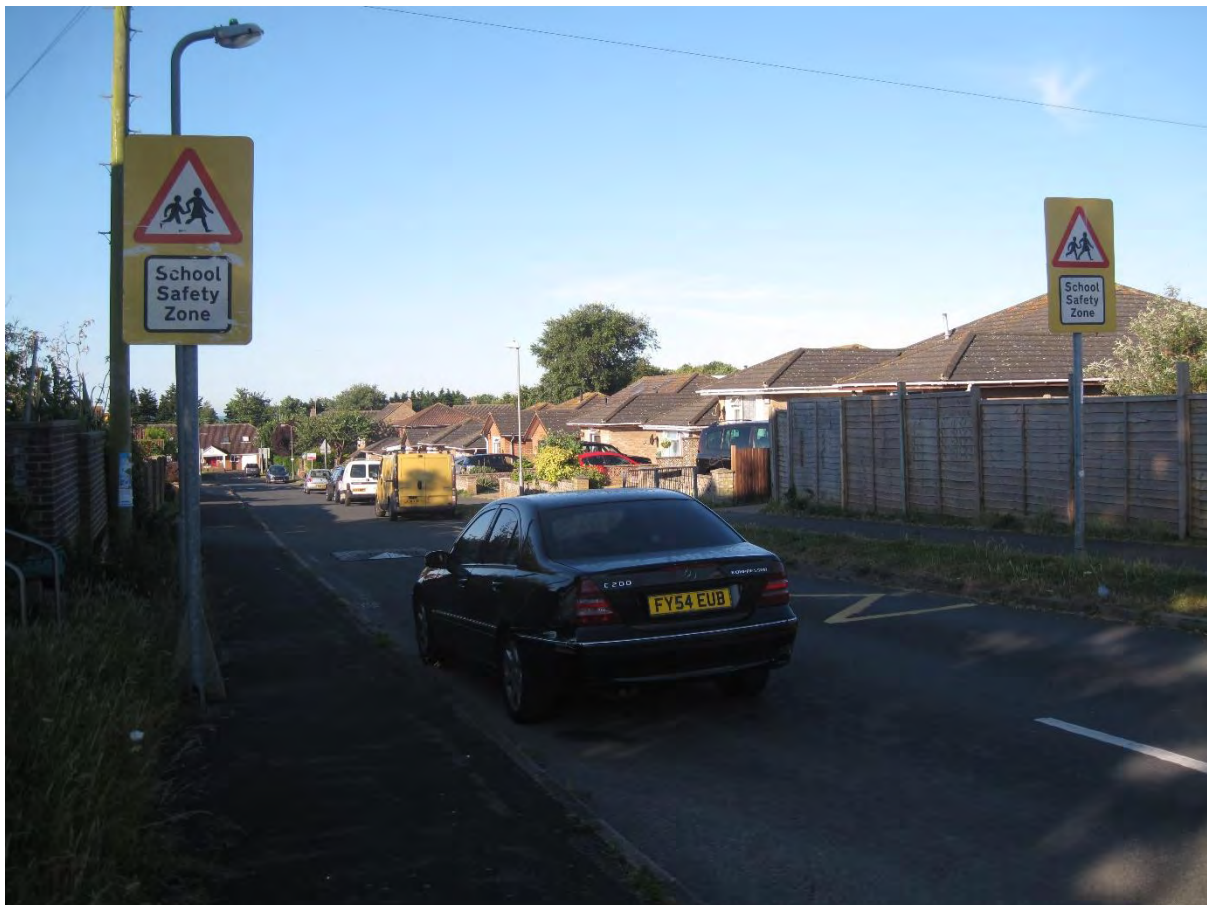
Cripps Avenue contains the pedestrian only access to the school. From its junction with Pelham Rise to its junction with Glynn Road, is a 20 mph traffic-calmed school safety zone. Low levels of parking were observed outside the peak school access periods. During the peak periods, the level of parking substantially increased, but did not reach its full capacity along its entire length; there were always spaces available. To this extent the table below of parking numbers expressed as a proportion of the total practical capacity is misleading. This is because, firstly, as noted on the table, three vehicles were included that were parked in The Sparrows without the total parking capacity being increased to allow for The Sparrows, and secondly, there was parking taking place in areas specifically excluded from the total. School related parking was concentrated in the northern section of Cripps Avenue to the north of the school entrance, taking place mainly on the eastern side and all around the corner of the junction with Pelham Rise. Parking also took place in the access to the yard at the junction with Pelham Rise. The parking around the corner and in the yard access had the potential to impede access, not only to and from Cripps Avenue, but in particular to the yard which is used by some substantial construction vehicles. There was also some parking on both sides of Cripps Avenue in some places on this northern section, achieved by vehicles parking half off the road to allow other vehicles to pass. Hence, the practical parking capacity of this small area could be considered to have been exceeded despite there being parking spaces within a very short distance.

Cripps Avenue looking south from Pelham Rise.

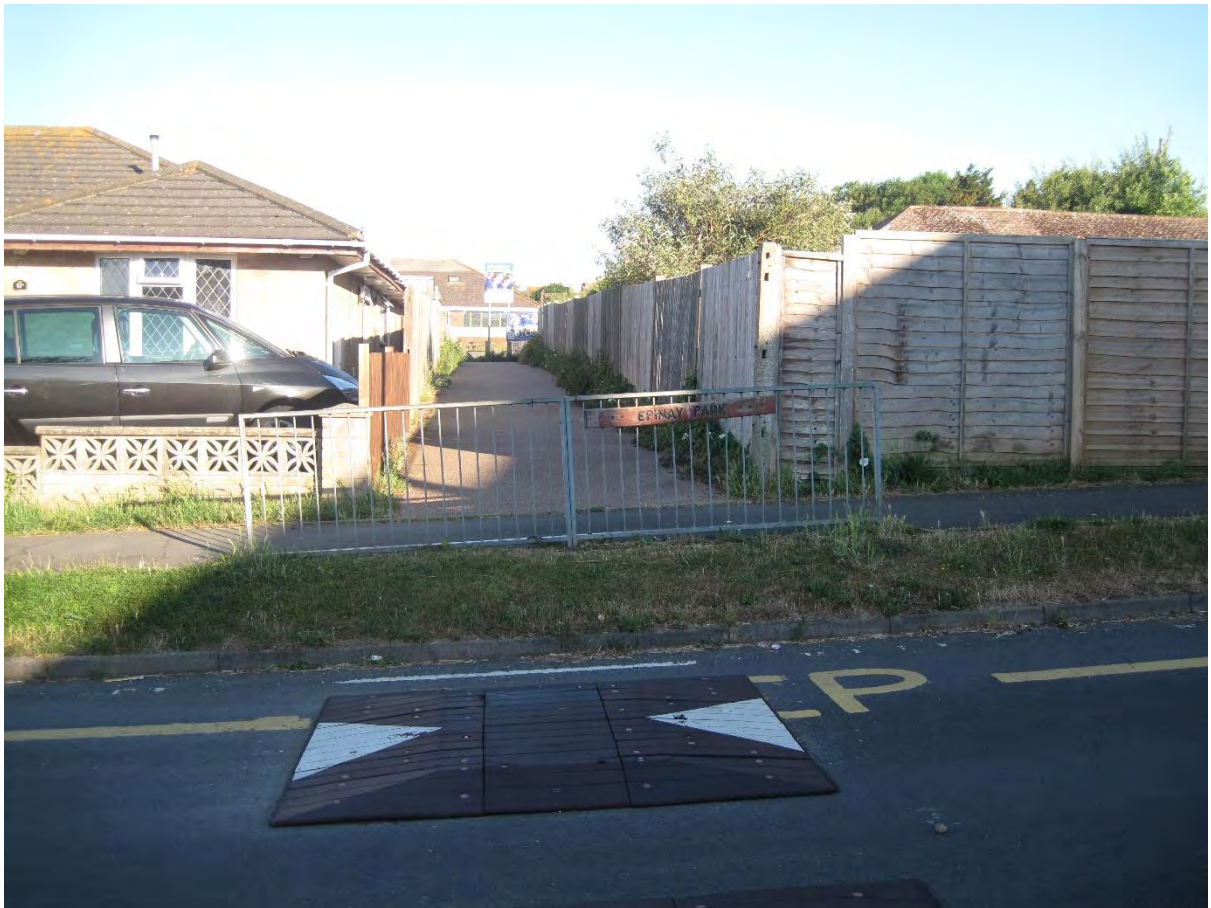
The school pedestrian access from Cripps Avenue
