Arboricultural Report

Tree Survey Arboricultural Impact Assessment & Tree Protection Plan

Land at the
Hookstead Centre
Goldsmith
Avenue
Crowborough
TN6 1RH

June 2016

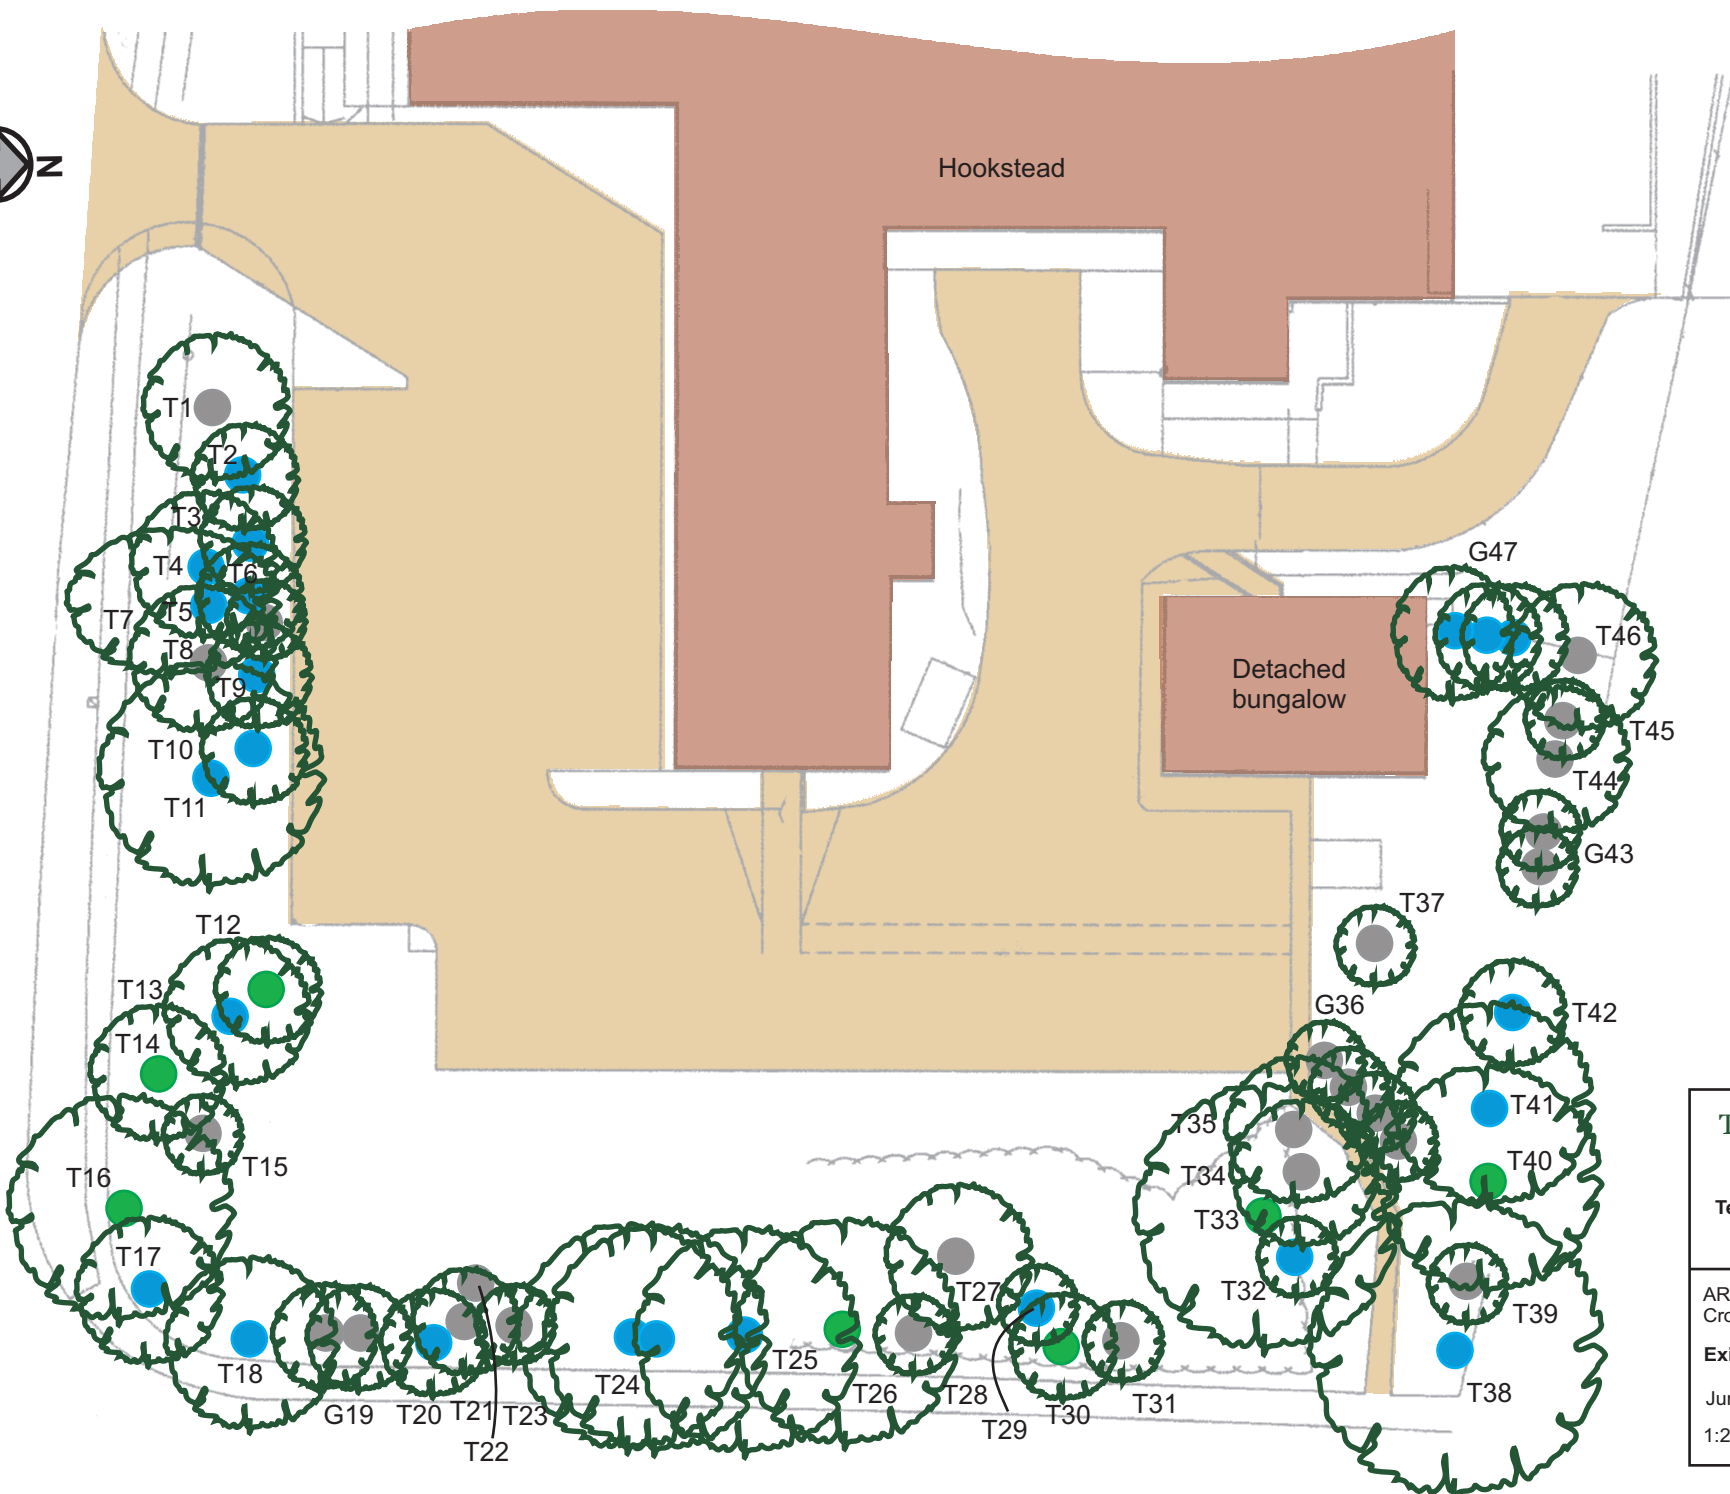
Existing Tree Plan

8.1 I surveyed forty three individual trees and four groups of trees in May 2016. All of these trees are illustrated at Appendix A and the survey information is appended to this report at Appendix C.

T12 cypress, T14 pine and T16 lime are all located on the southern Goldsmiths Avenue frontage.

T26 lime, T30, T33 and T40 pine are all located on the eastern Beacon Road frontage.

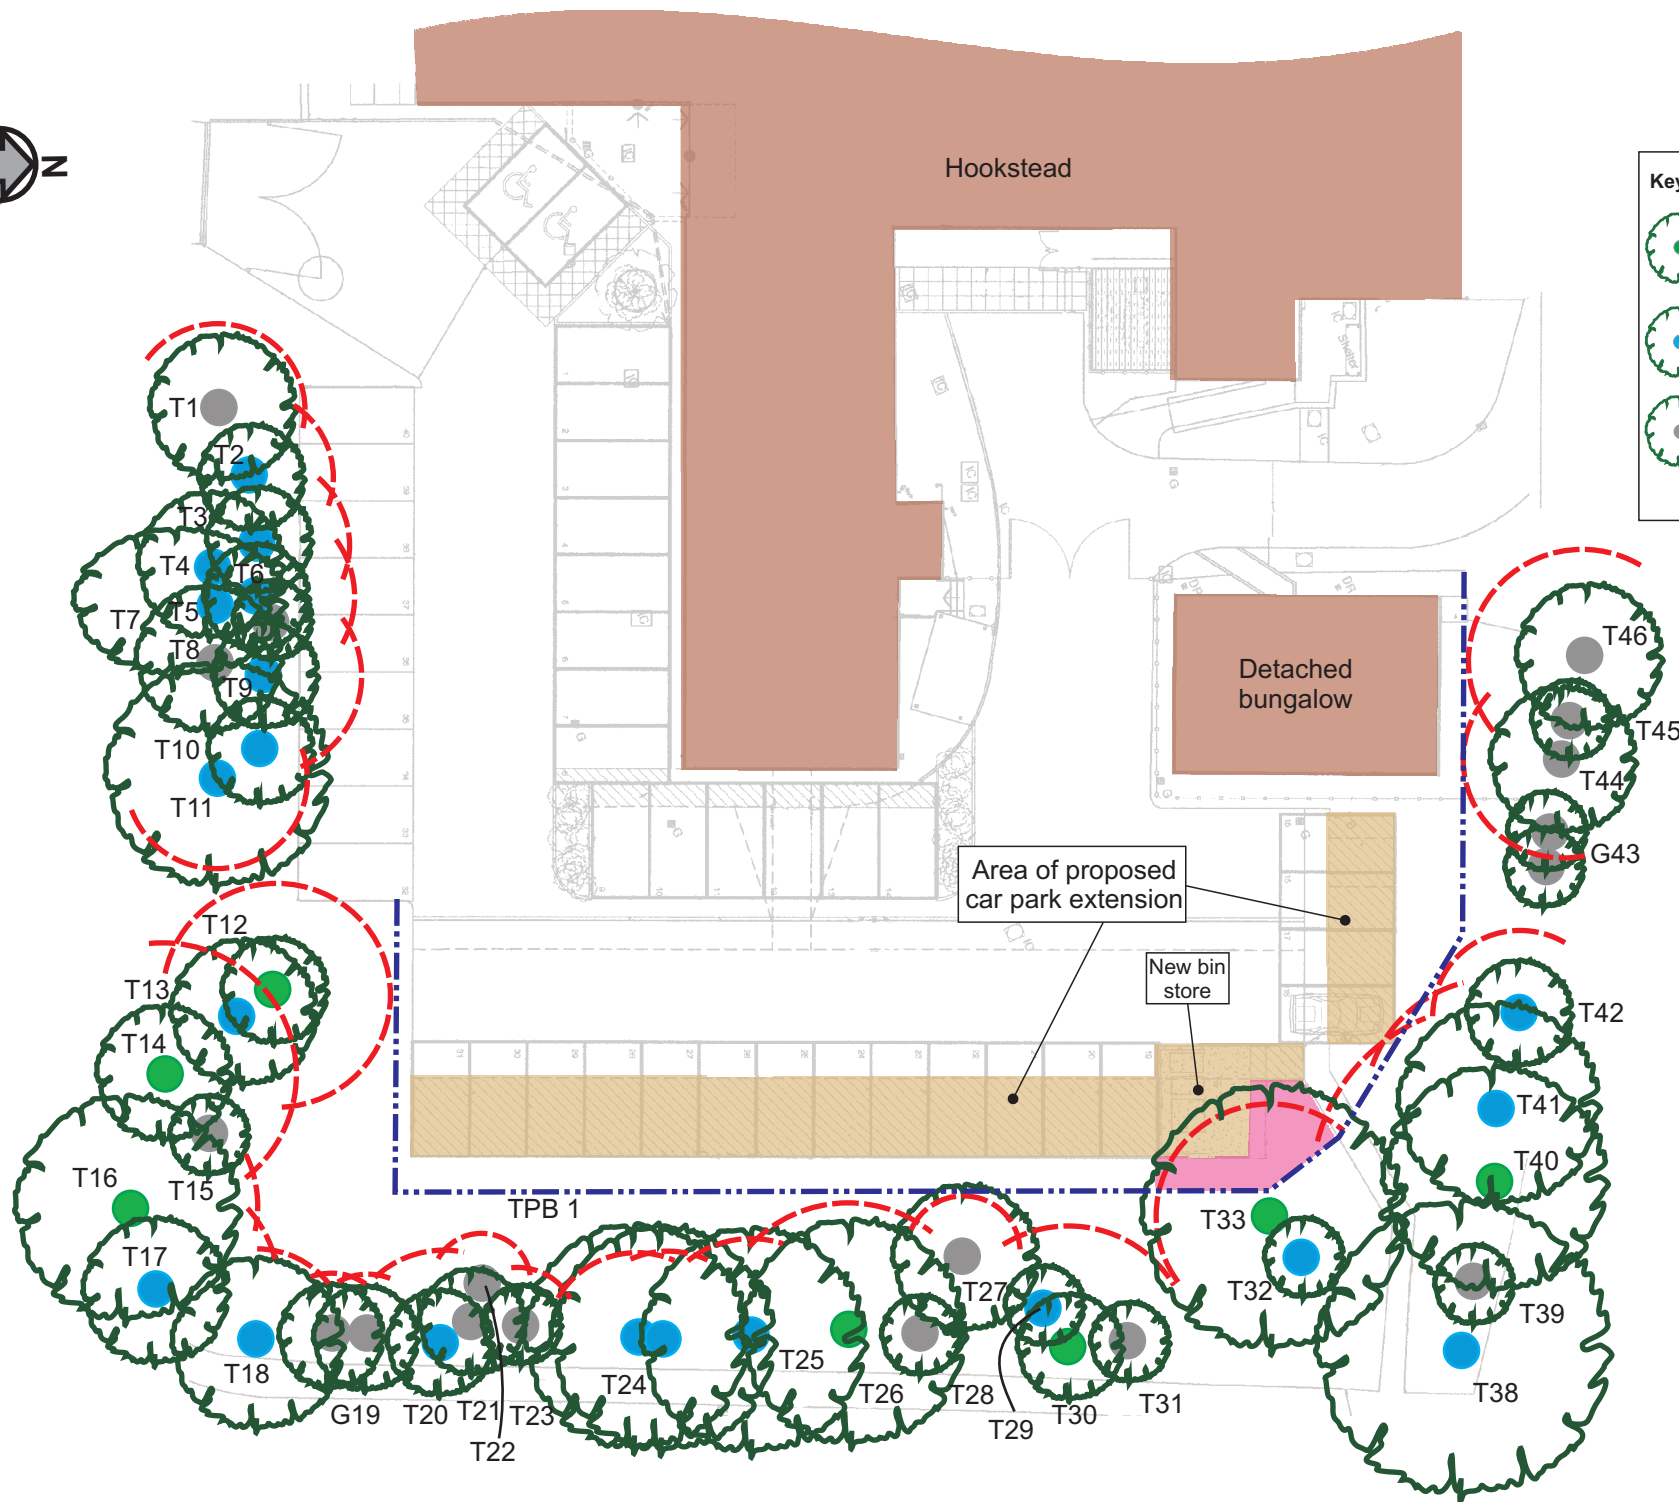
Tree Protection Plan

10.2.1 I have calculated the RPAs of the existing trees as recommended within BS 5837:2012. These areas are shown as a dashed red line around retained trees at Appendix B attached to this report, and each figure is included within the survey schedule at Appendix C.

10.2.2 Following the tree removal works, some aspects of the proposed development will either potentially encroach into the nominal RPAs of some retained trees or occur close to them. Details with regards to these encroachments, and the consequently recommended tree protection measures are given below:

The southwestern periphery of the nominal RPA of this tree encroaches into the development footprint of the proposed new bin area. The actual extent of construction activity which might result in excavation works within the RPA is limited and I would not necessarily anticipate that any significant roots would be present in the area of proposed excavation. If roots are encountered, however, the following method of working should be adopted:

All of the trees along these frontages will have works occurring close to their nominal RPAs as a result of the proposal to install new parking bays. In order to protect the roots of these trees during the construction period the installation of one Tree Protection Barrier (TPB1) is advocated. The extent of this barrier has been illustrated at Appendix B as an interrupted fence along both frontages – though allowance and access may have to be made to retain pedestrian access to the site. A specification for the design and installation of this barrier is detailed below.

The potential encroachment becomes more significant when allowance is made to accommodate the required working areas. Therefore, in order to protect the roots of this tree during the construction period the following protection measure is advocated in addition to the Tree Protection Barrier detailed above:

Temporary ground protection should be installed in an area to the west of this tree for the duration of the construction period. The extent of this ground protection has been illustrated in pink at Appendix B, and a specification for its design and installation is given below.
