Report issued:
17 September 2014

Bat Survey Report

Ringmer Primary School
Harrisons Lane
Ringmer
East Sussex
BN8 5LL

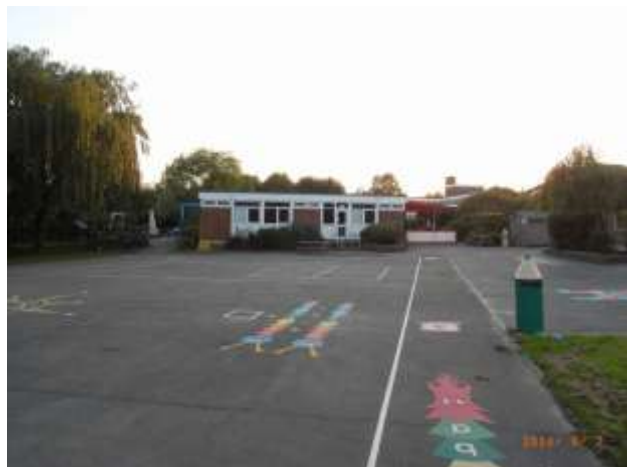
Photograph 1

View looking west towards the nursery building, This section of the building will be demolished, and re-built as a new structure (as shown in the site plan, Part 3 – see Appendix 4)

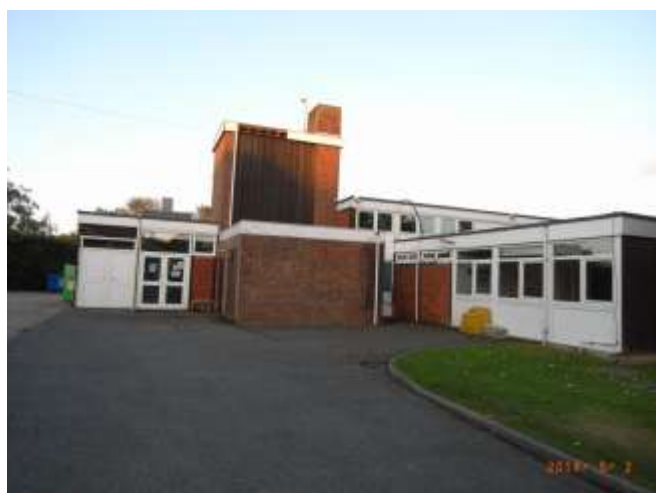
Photograph 2

View looking east towards the Existing Hall, Admin, Kitchen building, This section of the building will be retained (as shown in the site plan, Part 3 – see Appendix 4)

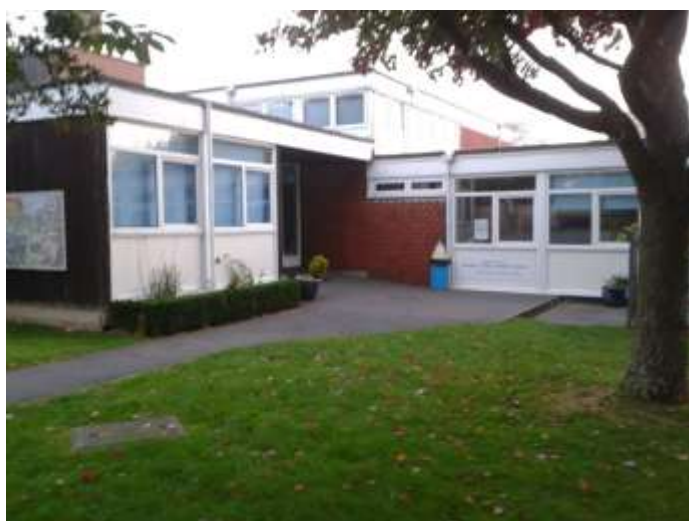
Photograph 3

View looking north-east showing the nursery building, This section of the building will be part demolished (as shown in the site plan, Part 3 – see Appendix 4)

The nursery building was considered to have limited roosting opportunities for bats based on the lack of a roof void. However, there was cladding on the outside of the building which could be used by crevice-dwelling species such as pipistrelles.

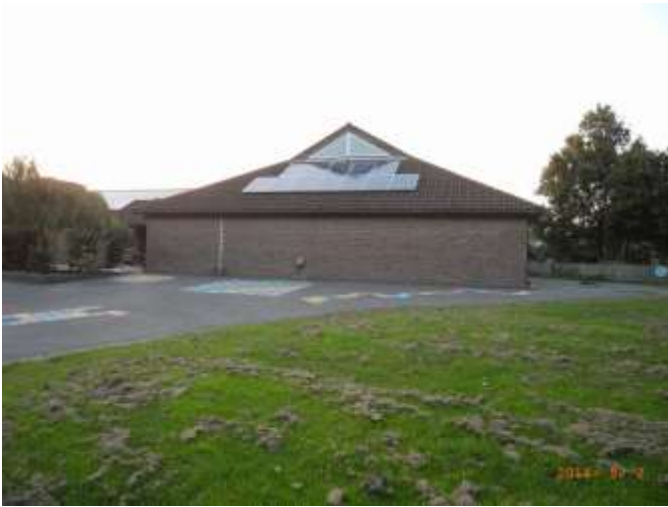
Photograph 4

View looking north showing the Juniors building. It is intended to extend six of the classrooms of this building (approx. 1.5 m each).

It is unlikely that the existing roof void would be modified. However, there would be some disturbance and modifications to existing walls as well as noise and vibrations during construction work. It was unclear whether the walls were cavity-filled.

On the other hand, the Juniors building was considered to have slightly more roosting opportunities such as the presence of a large roof void, roof tiles, lead flashing and soffit boards. However, on close inspection there appeared to be few gaps, and the soffit boards appeared to be well sealed.

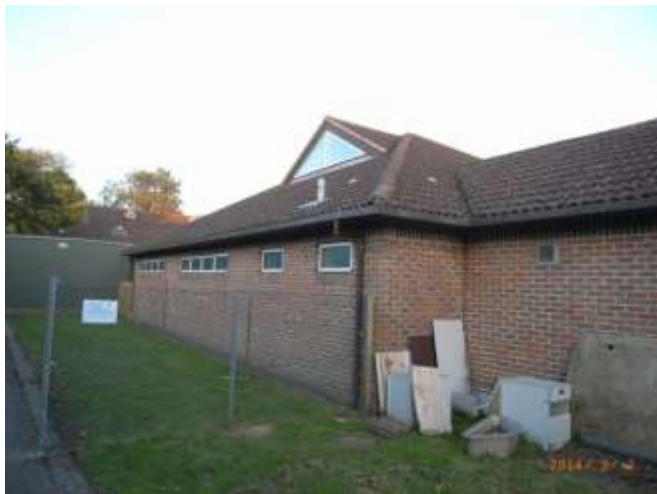
Photograph 5

View looking north-east showing the Juniors building, It is proposed to extend one classroom on this side of the building by 1.5 m.

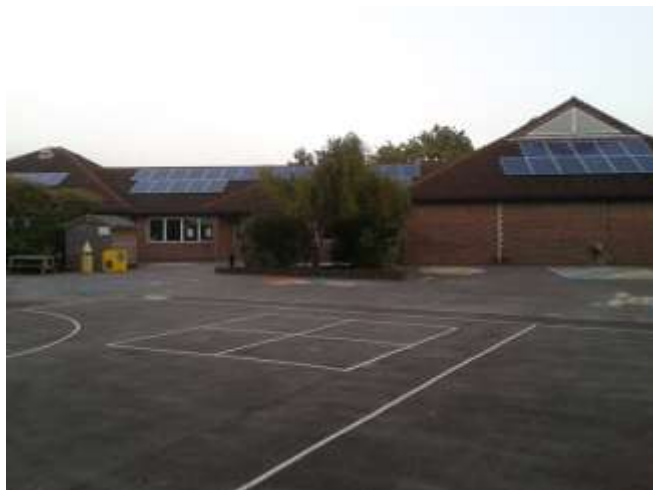
Photograph 6

View looking north-west showing the Juniors building, It is proposed to build a temporary link from this building to the new nursery reception building. In addition, it is proposed to join two buildings together on the western corner of this building.

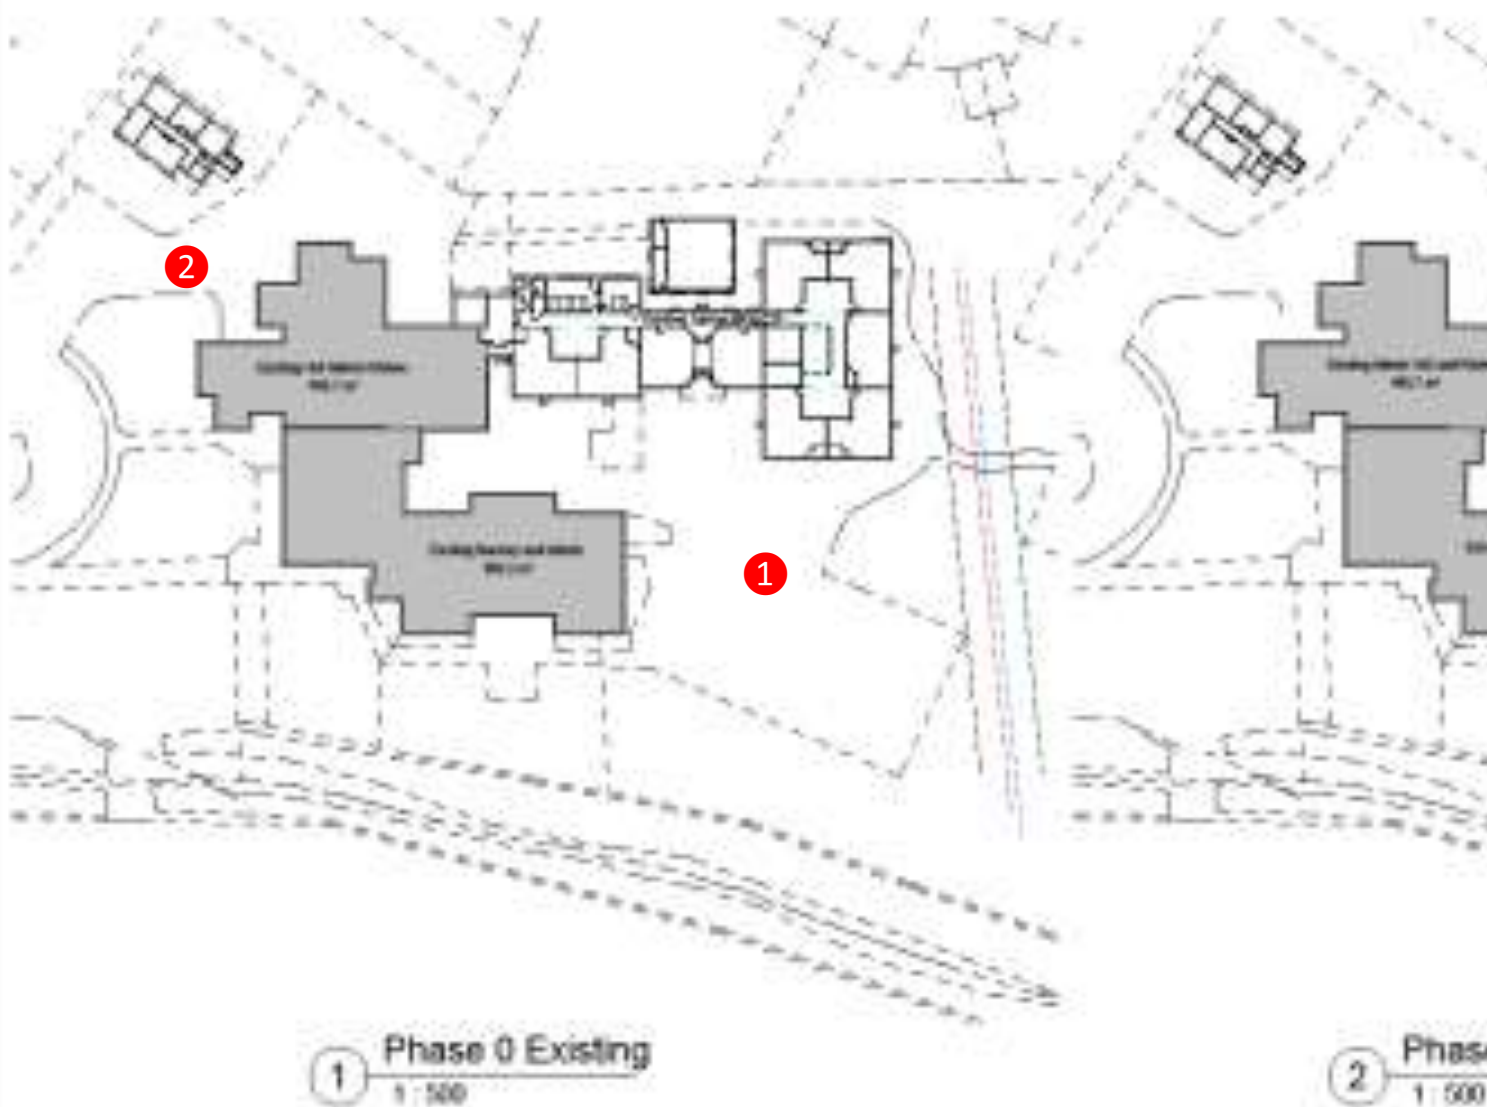
Location of surveyors during emergence surveys

Please note that both surveyors were able to walk around and were not fixed to their survey posts, so that all parts of the two buildings could be adequately surveyed. In addition, an ANABAT recording device was used on each survey, including the dawn surveys.
