Appendix 12-D Mammals

12-D.1 Bats

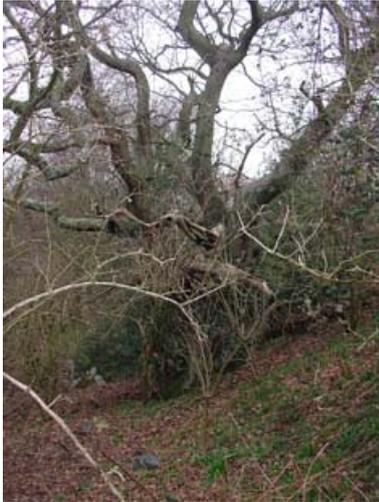
12-D.1.33 This area is sparsely wooded with several trees that offer potential for roosting Bats. The key trees include a mature oak (*Quercus sp*) (Photograph 1) with several holes, splits and loose bark and a Silver Birch (*Betula pendula*) with several holes present. These trees are considered to have **High Bat Potential**.

Photograph 1 Bat Potential
Tree at Target Note 1

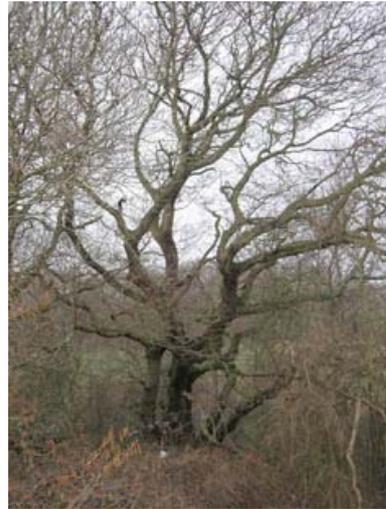
12-D.1.34 This area comprises of the hedgerow bordering the eastern side of the railway and consists of several small and medium sized oak and Ash (*Fraxinus sp*) trees which are Ivy (*Hedera helix*) covered and offer low potential. However, a number of mature oak trees (Photograph 2) are present which have many holes splits and cracks offering ample Bat roost potential. These trees are considered to have **High Bat Potential**.

Photograph 2 Bat Potential Tree
from Target Note Area 2

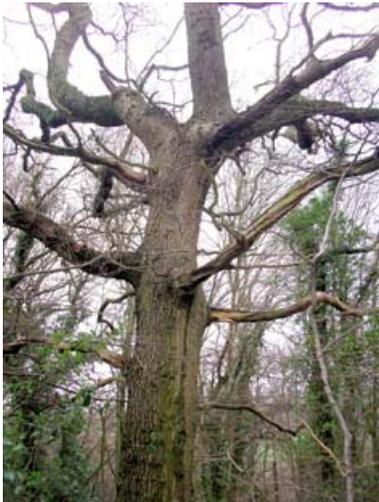
12-D.1.37 This area comprises of the western side of Crowhurst Road and the adjacent copse. There are several mature oak and Ash trees present with varying degrees of Ivy covering and splits present (Photograph 3). These trees are considered to be of **High Bat Potential**.

Photograph 3 Potential Bat Roosting
Trees with Splits and Holes Located at
Target Note 5

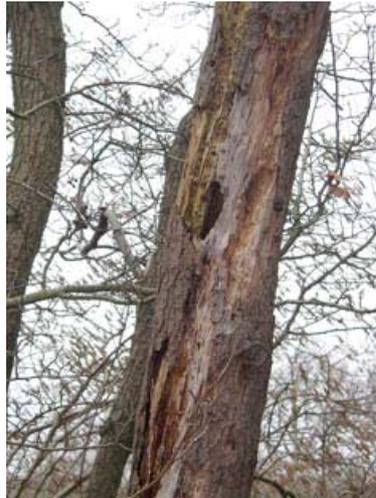
12-D.1.39 This area consists of the stream bordering the western boundary of the land owned by Upper Wilting Farm. The area has a number of mature trees with standing dead wood, splits and holes which offer potential bat roosting opportunities (Photograph 4). Adjoining this area is an Alder (*Alnus glutinosa*) copse that has many trees featuring standing dead wood, splits and cracks. In addition this area offers suitable bat foraging habitat and is considered to be of **High Bat Potential**.

Photograph 4 Potential Bat
Potential Trees with Splits and
Holes Located at Target Note Area 7

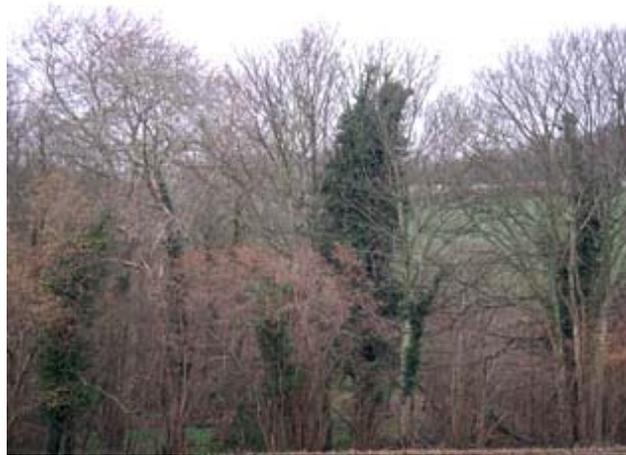
12-D.1.40 This woodland strip is a continuation of Target Note 7 which follows the line of the stream and is linked to Decoy Pond Wood at its southern end. There are several trees with varying amounts of Ivy cover, splits and cracks that offer good Bat roosting potential (Photograph 5). This area is within close proximity to ponds and offers suitable commuting, foraging and roosting habitat and as a result it is considered to be of **High Bat Potential**.

Photograph 5 Ivy Covered Trees and Standing
Dead Wood with Bat Potential within Target Note Area 8

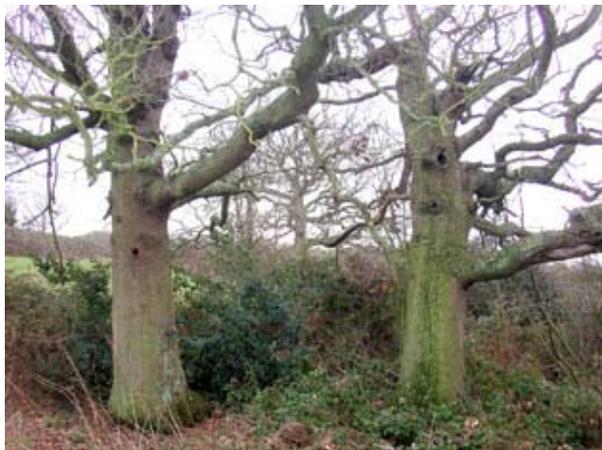
12-D.1.42 This area consists of two mature Oak trees with several holes (Photograph 6), splits and cracks offering ample opportunity for Bats to roost. These trees are considered to offer **High Bat Potential**.

Photograph 6 Two Trees located at Target
Note 10 Showing Potential Bat Roost Holes

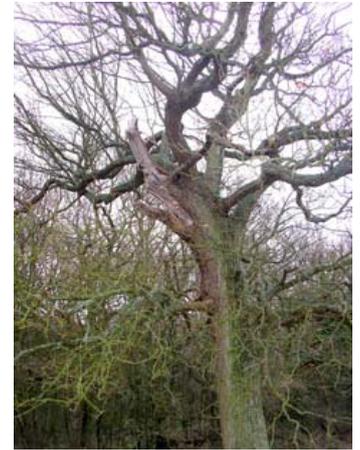
12-D.1.43 This area consists of mature Oak trees with holes and splits (Photograph 7) providing ample opportunity for bats. The adjacent hedgerow has a few medium-sized Ivy-covered oak trees offering low bat roosting potential, however this hedgerow has good bat foraging and commuting potential. This area is considered to offer **High Bat Potential**.

Photograph 7 Single Oak
located at Target Note 11
showing the broken branch
with splits and cracks

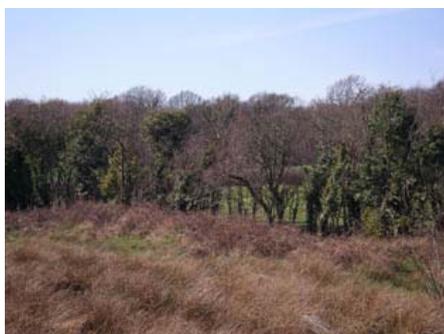
12-D.1.48 This area comprises three medium sized ivy covered oak trees (Photograph 11-4A.8) offering some roosting potential for bats. This area is considered to be of **Medium Bat Potential**.

Photograph 8 An oak
located in Target Note 16

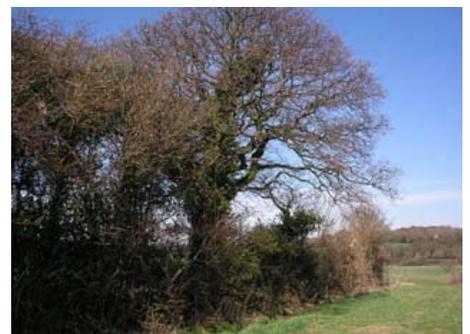
12-D.1.50 This area consists of a mature Hawthorn hedgerow (Photograph.9) with some dense Ivy covering over much of it. The thicker areas of Ivy covering the tree are considered to offer **Medium Bat Potential**.

Photograph 9 Hedgerow
located at Target Note 18

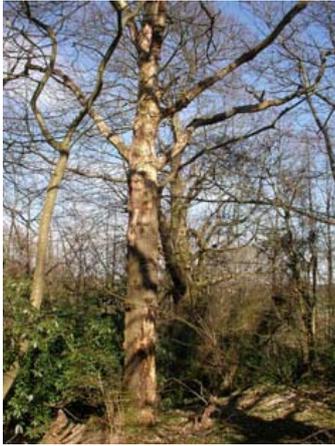
12-D.1.51 This area of woodland is located to the west of the Scheme. There are many mature trees with splits and cracks offering excellent potential for roosting bats (Photograph 10). In addition, the hedgerow running from east to west from the woodland is used as a commuting route by bats. This area is considered to be of **High Bat Potential**.

Photograph 10: Tree with Splits
Located at Target Note 19

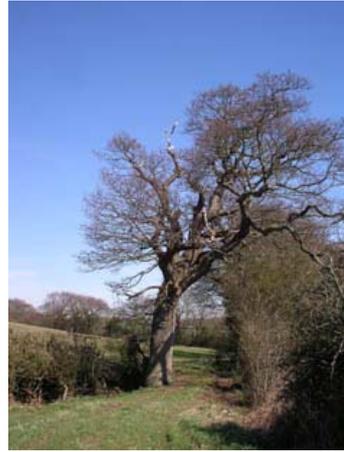
Photograph 11: Mature Oak
Located at Target Note 20

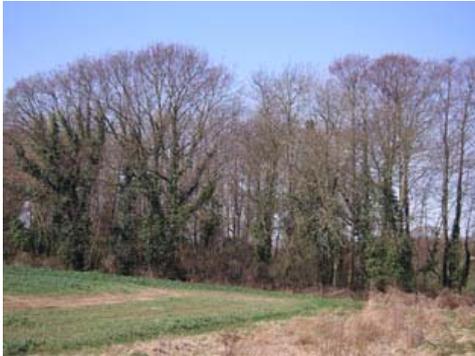
12-D.1.53 This area consists of a small copse (Photograph 11-4A.12) with several Ivy covered trees, and many trees with suitable splits and cracks that offer suitable Bat roosting potential. This area is considered to be of **High Bat Potential**.

Photograph 12: Small Copse located
at Target Note 21

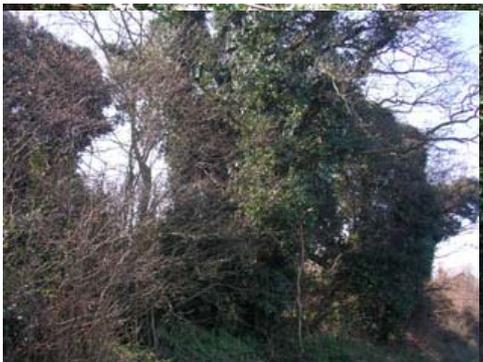
Photograph 13 Ivy Covered
Trees located at Target Note
22

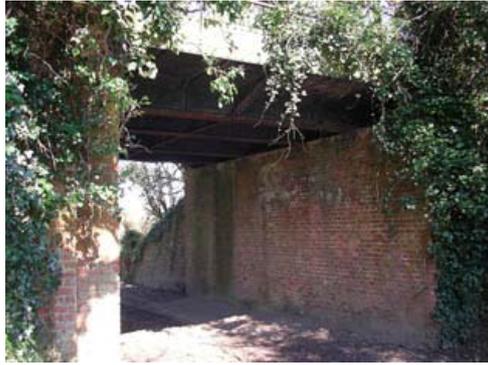
12-D.1.55 This area consists of a bridge located along the line of the disused railway (Photograph 14). The bridge appears in good condition with no obvious cracks in the brickwork. Some Ivy covering is present, which could offer some Bat potential. The bridge is considered to be of **Medium Bat Potential**.

Photograph 14: Bridge Located at Target Note 23
Showing Covering of Ivy

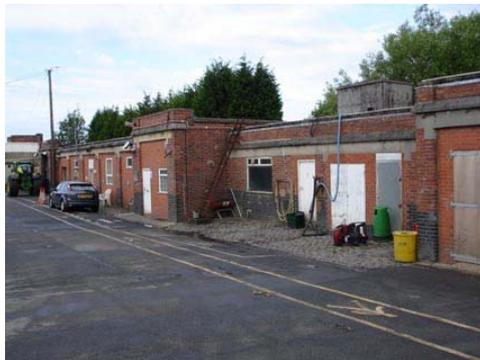
12-D.1.59 The depot consists of a series of flat roofed workshops and machinery stores the majority of which are in constant use (Photograph 15). The buildings are largely of brick construction with flat felt clad roofs. The felt cladding overlaps the fascia area of these buildings but generally this area is well fitted and there are no gaps that would provide Bat roosting opportunities. On the eastern side of the site is a building with a wooden clad water tower this tower was investigated but was found to be rotten and letting in water, as a result it was considered unsuitable for bats. In the west of the site a workshop building has wooden fascias with some gaps, these gaps were investigated and found to extend for a short distance into the back of the fascia area. Investigation of these areas failed to produce any evidence that bats were utilising these fascias. A single asbestolux barn is present on the site, this is utilised as a machinery workshop. Along the south side of the building is an asbestolux fascia area there is a gap between the fascia and the wall that could potentially provide bat roosting opportunities, however, detailed investigation failed to produce any evidence of bats. Generally, these buildings are considered to offer no or very limited bat roosting potential.

Photograph 15
Council Depot on London Road

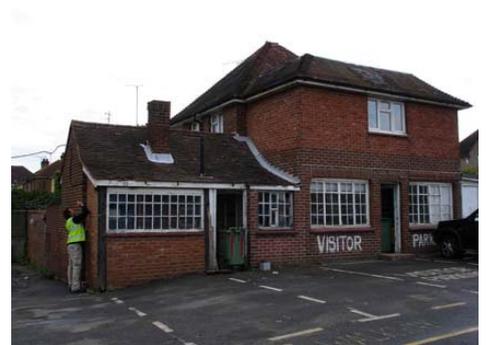
12-D.1.60 On the northern boundary of the depot is a residential property (Photograph 16). This building is in a moderate state of repair and there are generally few areas that would allow bat access to the building. On the west and north elevations a number of gaps were noted in the soffit area and there were a number of gaps around the ridge tiles on the south elevation which could allow bat access into the building. Inspection of the roof space revealed many mouse and rat droppings, however, despite gaps around the eaves on the north elevation and a suitable internal roof structure there was no evidence that bats use this building.

Photograph 16
Residential Property
adjacent to Council Depot

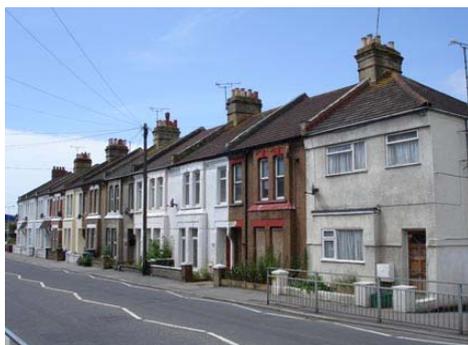
Photograph 17 East Elevation of
London Road Buildings

12-D.1.61 The London Road buildings consist of 16 terraced houses, most of these buildings are unoccupied but at the time of the survey 3 were occupied. All buildings are in a state of disrepair, the eastern elevations that front the London Road (Photograph 17) have numerous gaps around the soffit and fascia areas whereas the western elevations (Photograph 18) at the rear of the buildings are generally well maintained. The roofs of these buildings are a combination of pan tiles and slates, all roofs are generally well maintained and there are relatively few potential access points for bats. All roof spaces of these buildings were inspected internally and all are typical trussed roof designs. Along the eastern side of these buildings there were extensive gaps that would allow bats access to the roof void. However, despite the potential for roosting that these buildings offer there was no evidence that any were being utilised at the time of the survey by bats for roosting. There were no droppings present within roof voids and there was no evidence that Bats were entering these buildings. Bat activity surveys carried out along London Road and along the disused railway line to the west produced a very low level of bat activity with just 1 record of a foraging common pipistrelle in the vicinity. It is considered that the urban location of these buildings and low level of bat activity in the area would mean that these buildings would not be used by bats on a regular basis.

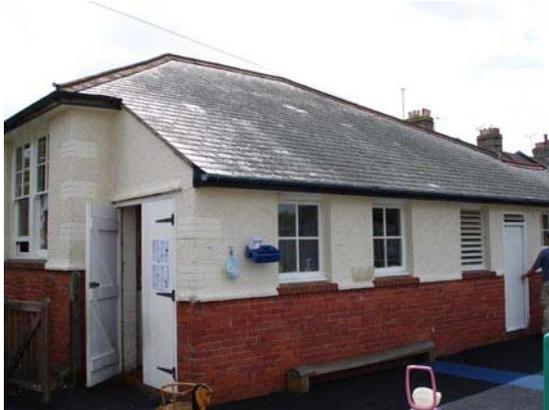
12-D.1.62 The nursery school (Photograph 19) was subject to an external examination but access was not gained to the roof void. The school has a combination of asbestolux and slate roofs, these are generally well maintained and roofing materials well fitting. The porch on the northern elevation of the building has a number of loose slates and a single Bat dropping was located on the roof. This Bat dropping probably belonged to a pipistrelle. The soffits and fascia areas of the buildings are generally well maintained and there appear to be few potential access areas for bats.

Photograph 19 Nursery School

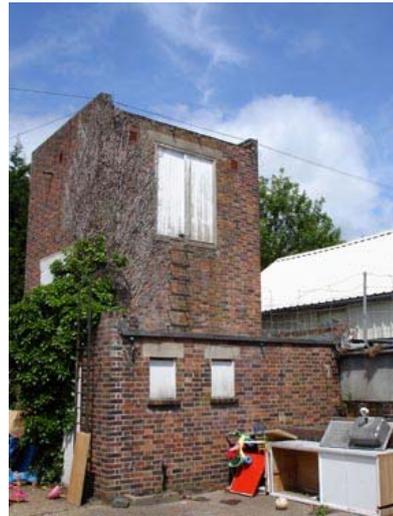
Photograph 20 Brick
Tower to North of
Nursery School

12-D.1.63 To the north of the nursery and on the southern boundary of the Council depot lies a brick tower (Photograph 20). This tower has a two level flat roof and access doors on the second storey. The only potential bat access to this building appeared to be above the wooden access doors and into the cavity vents, however, there was no evidence that bats are entering this building.
