Appendix 12-H Fish and Crayfish

12-H.1 Fish

12-H.2 Crayfish

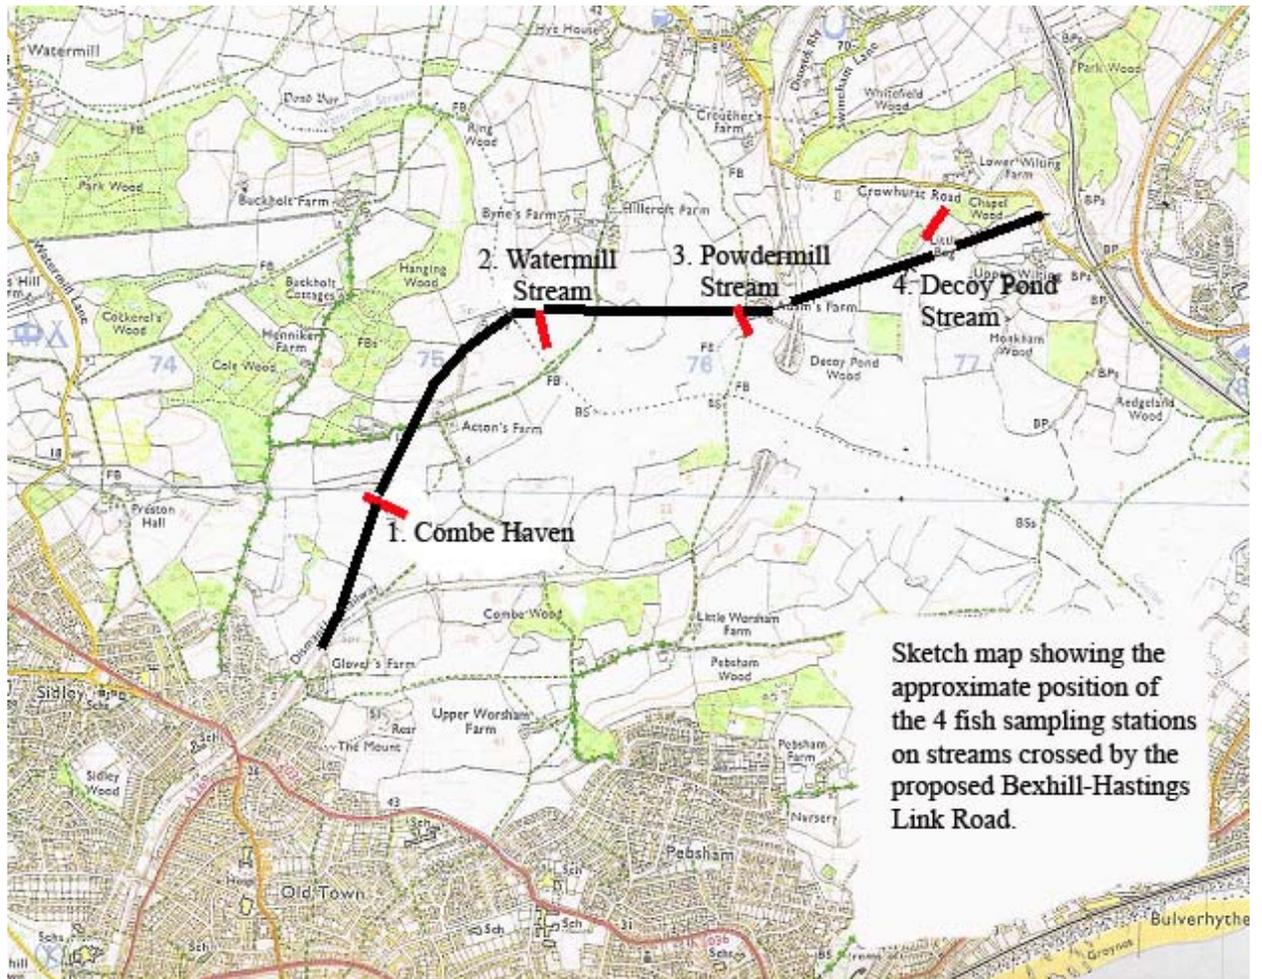
Figure 12-H.1 Sketch map showing the approximate position of the 4 sites that were electric fished in May 2006. The approximate line of the Scheme is shown in black.

8A.1.3 The positions of the sites are shown in Figure 12-H.1.

8A.1.4 Site 1 (Figure 12-H.1 & Figure 12-H.2) was situated on the Combe Haven, a small, flowing, ditch about 1 m in width, which was heavily overgrown with herbaceous plants. The streambed was muddy and water depth rarely exceeded 30cm, with the exception of deeper pools immediately above and below the footbridge.

8A.1.5 Site 2 (Figure 12-H.1) was situated on the Watermill Stream close to the point where the stream was crossed by a footbridge. This stream was a man-made drainage ditch with steep parallel banks about 4m wide with a soft mud substrate. Water depth exceeded 1m in places, and flow was barely detectable. Because of the width and depth of this stream, each bank was individually fished, giving a total of 6 passes along a 25m section.

8A.1.6 Site 3 (Figure 12-H.1 & Figure 12-H.3) was situated on Powdermill Stream, a small flowing stream between 1 and 2m in width which was heavily overgrown with herbaceous plants and some trees. The channel was deeply cut, with a bank height of up to 2m. The substrate was predominately gravel, with occasional muddy sections.

8A.1.7 Site 4 (Figure 12-H.1 & Figure 12-H.4) was situated on Decoy Pond Stream a small flowing stream between 0.5 and 1 m in width. This stream had cut a channel more than 2m deep, and in places there were small waterfalls with deeper pools more than 75cm deep. The normal depth was less than 30cm. The stream was bordered with herbaceous plants and trees on one side, and a field of barley on the other.

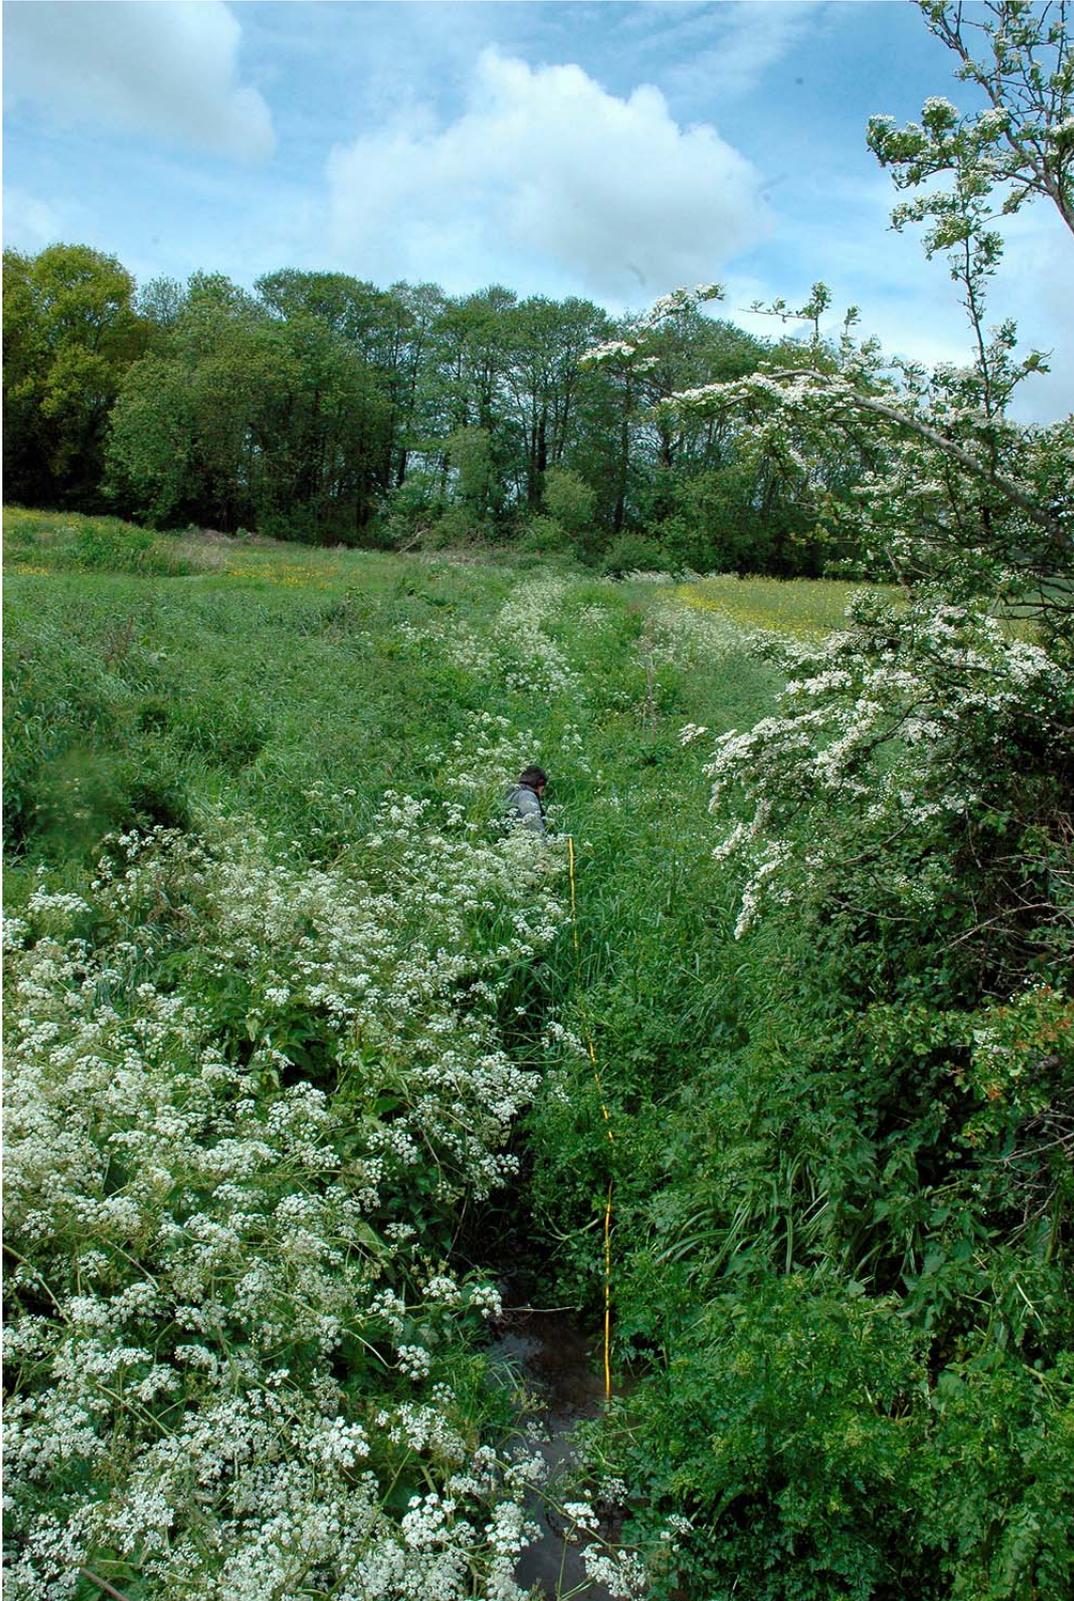
Figure 12-H.2: Combe Haven Stream during electric fishing.

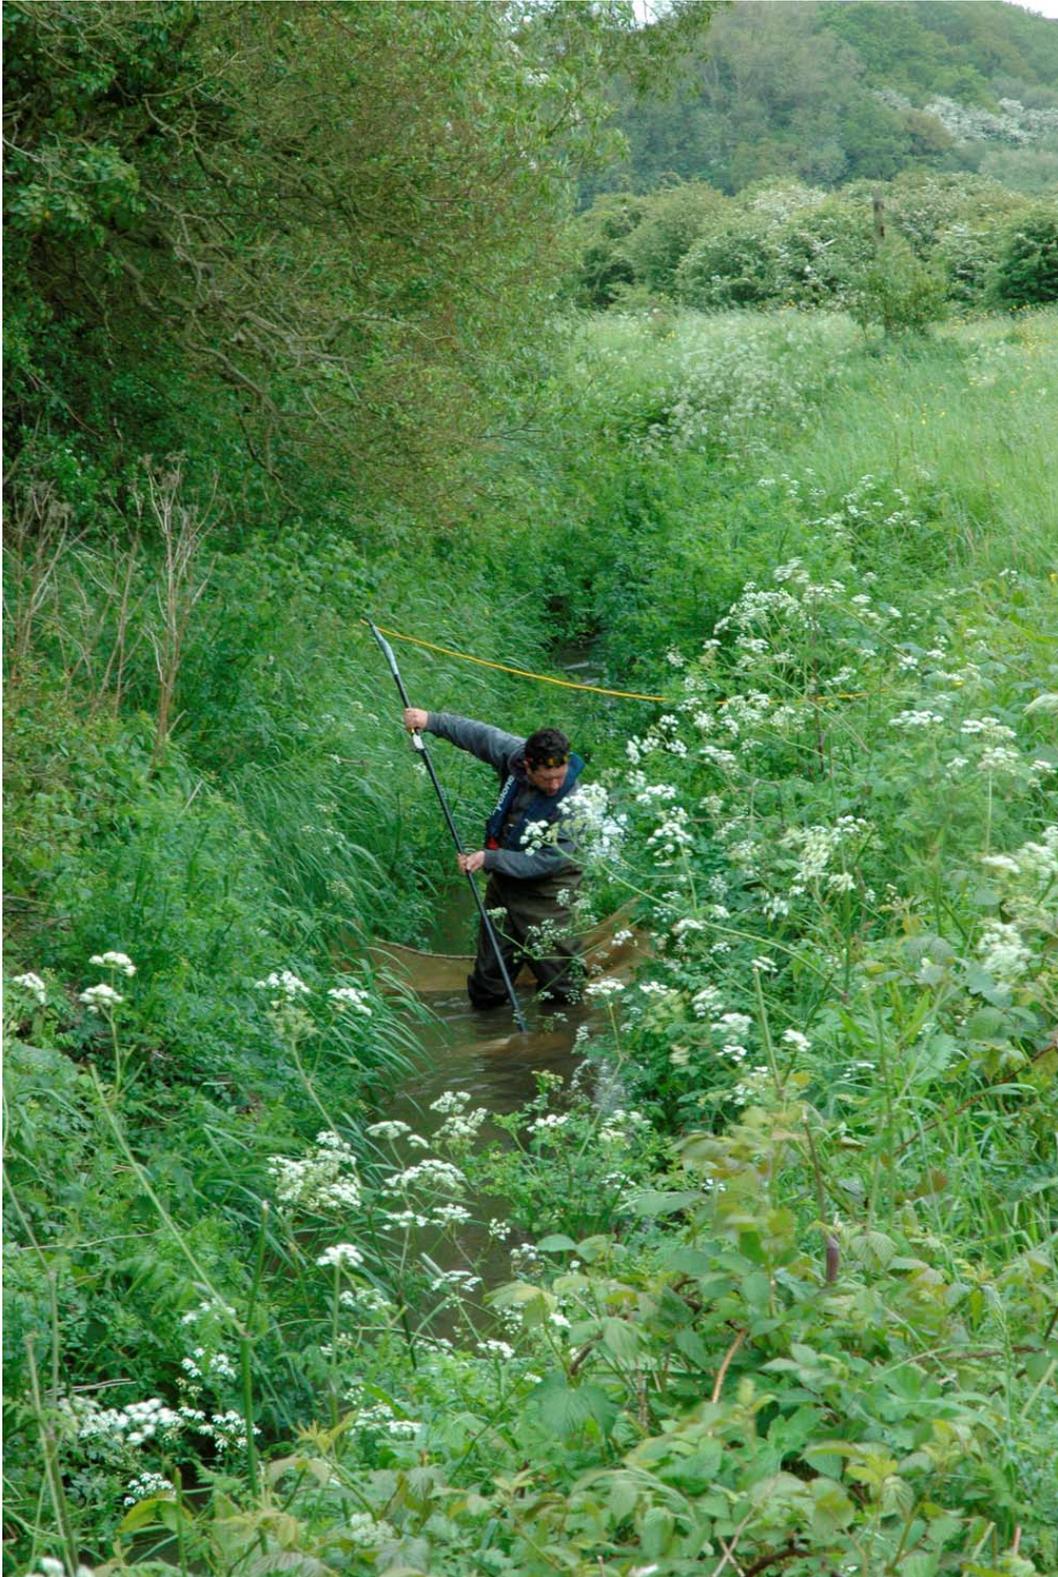
Figure 12-H.3: Powdermill Stream during electric fishing. The fisherman is just starting an upstream sweep and is standing directly in front of the stop net.

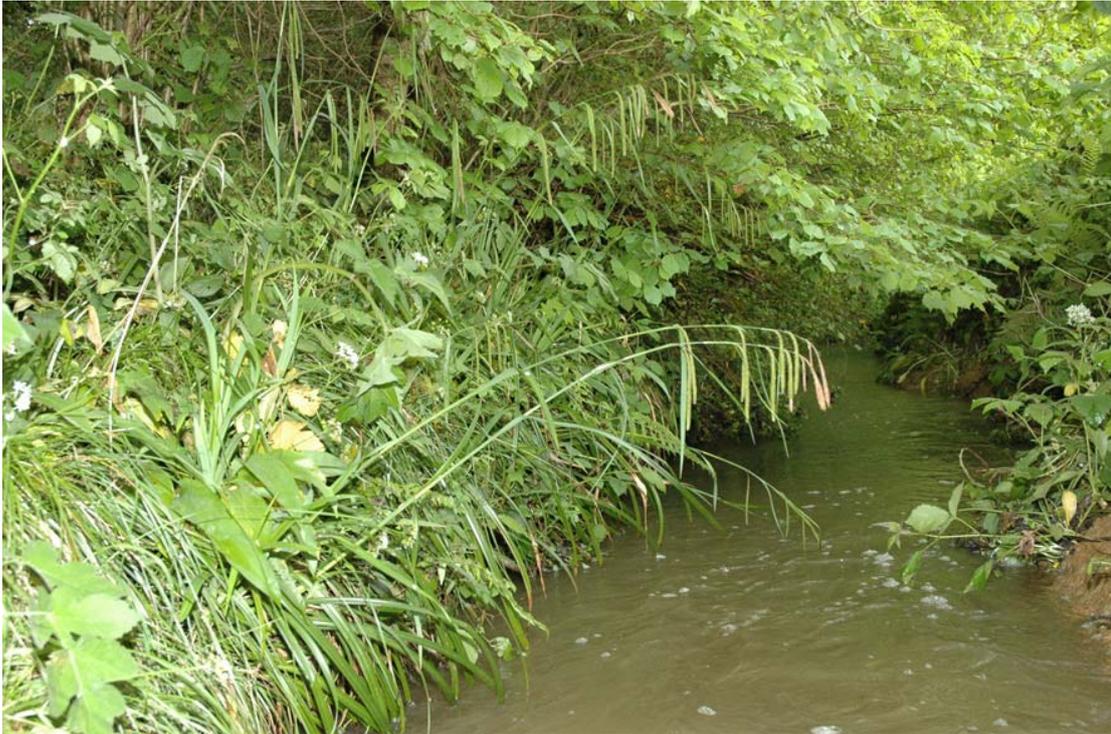
Figure 12-H.4: A close-up photograph of the Decoy Pond Stream. This picture does not show the height of the banks.

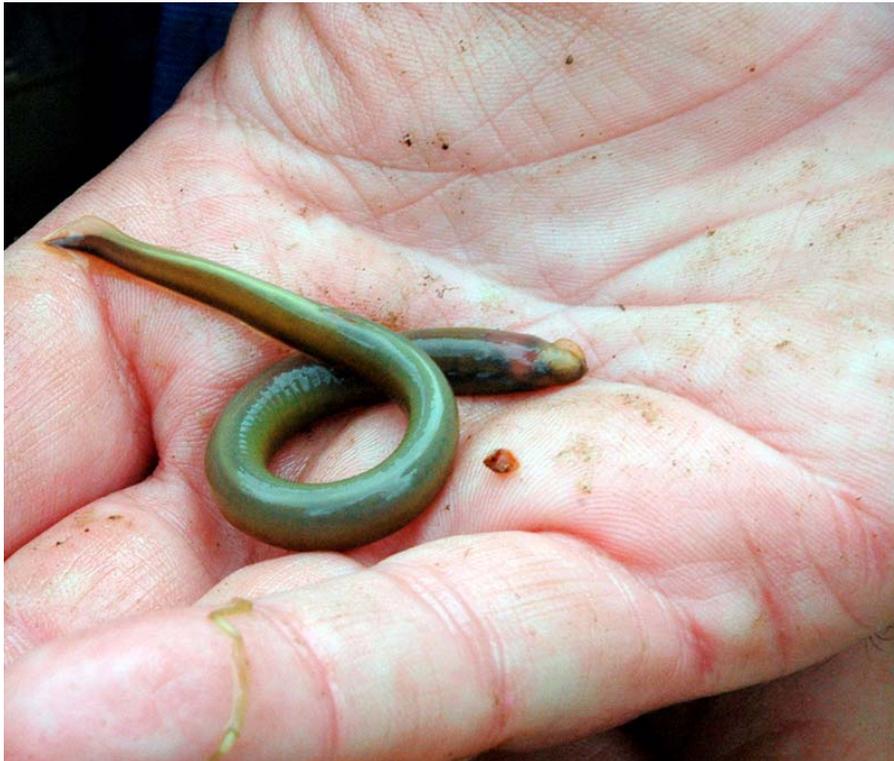
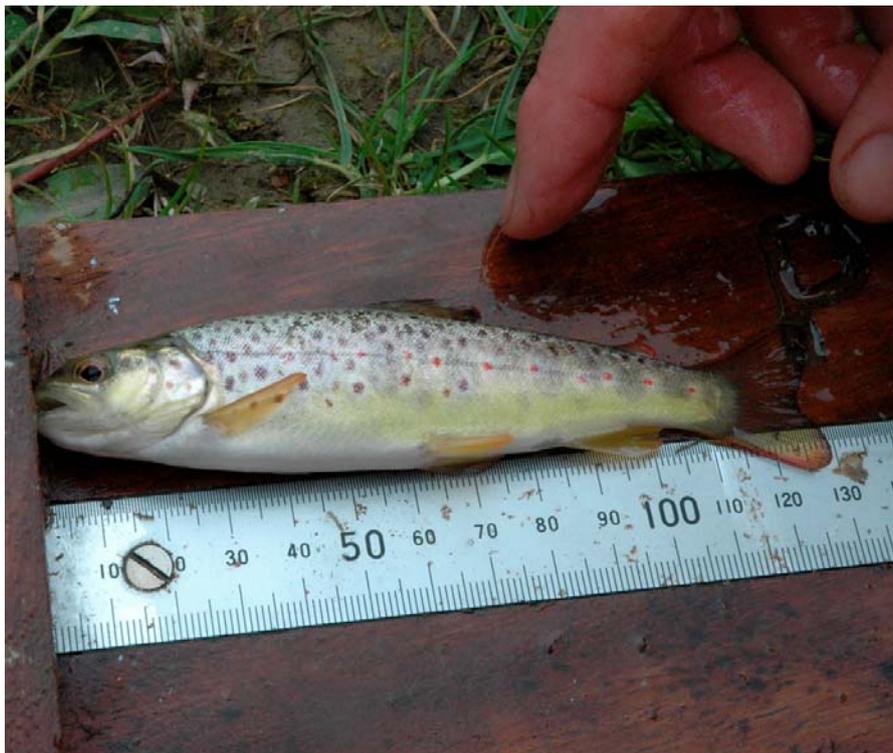
Figure 12-H.5: Lamprey and brown trout smolt caught in the Powdermill Stream, May 2006.

8A.1.11 The six species of fish recorded during the survey are listed in Table 12-H.3. This stream can be characterised as a lowland trout-lamprey nursery (see Figure 12-H.5). Brown trout, *Salmo trutta*, smolt density was approximately 0.2 individuals per square metre of water surface. The most abundant fish in this section were lamprey. It is difficult to distinguish between river, *Lampetra fluviatilis*, and brook lamprey, *Lampetra planeri*, ammocoetes in the field, so possibly one or both of these lamprey species was present. Lamprey are difficult to sample quantitatively, and it is notable that the number caught did not decline between sweeps. Further, at the end of the third sweep 10 lampreys were found retained in the lower stop net. The minimum lamprey density for this stretch was 0.88 lamprey late ammocoetes per square metre water surface. It is likely that the true density would have been above 1 individual per square metre of water surface.

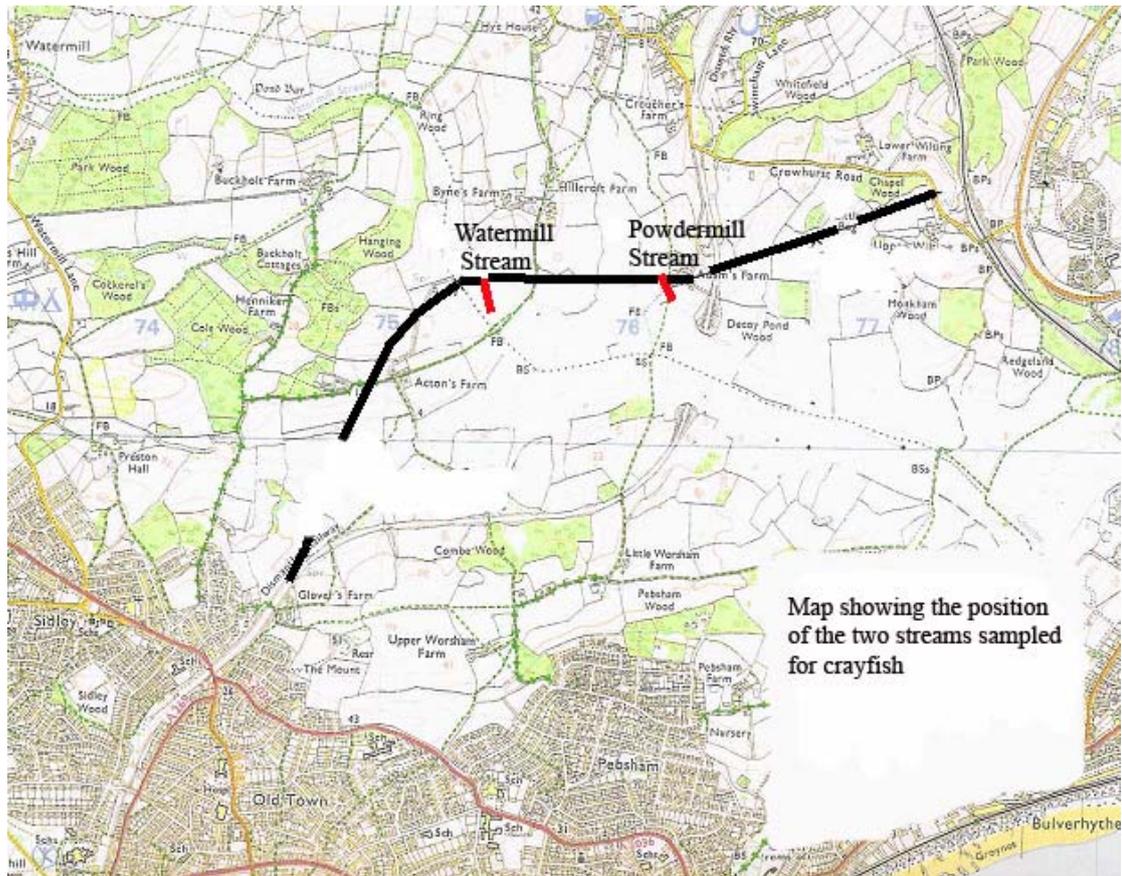
Figure 12-H.6: Map showing the approximate position of the sites that were electric fished in May 2006. The approximate line of the Scheme is shown in black.

12-H.2.3 Sampling for Crayfish was undertaken on Watermill and Powdermill Streams on 29th and 30th June and 20th July 2006. The positions of the sampling sites are shown in Figure 12-H.6, and pictures of the Streams in Plate 2. Site 1 (Plate 2A) was situated on the Watermill Stream close to the point where the stream was crossed by a footbridge. This stream was a man-made drainage ditch with steep parallel banks about 4m wide with a soft mud substrate. Water depth exceeded 1m in places and flow was barely detectable. Because of the width and depth of this stream it was only possible to use trapping methods. Site 2 (Plate 2B, C) was situated on Powdermill Stream, a small flowing stream between 1 and 2m in width which was heavily overgrown with herbaceous plants and some trees. The banks were deeply cut, with a bank height of up to 2m. The substrate was predominantly gravel, with occasional rocky and muddy sections. The depth and flow in this stream allowed hand searching to be undertaken.

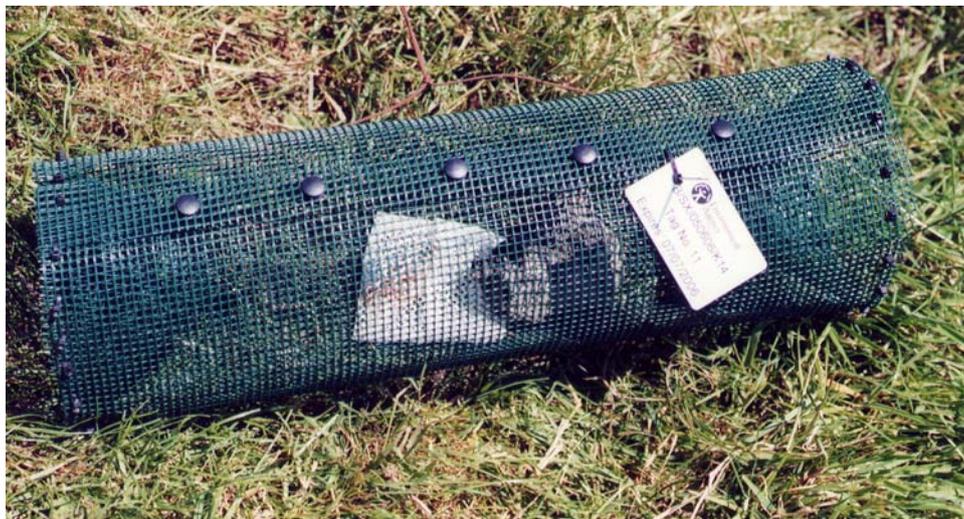
Figure 12-H.7: Photograph of a baited and tagged Crayfish trap.

12-H.2.4 In June, baited traps (Figure 12-H.7) and manual survey methods were used, while in July only a manual survey was undertaken. The sampling protocol followed the methods of Peay (2003). In June, 8 baited traps were placed overnight at about 10m intervals in the Watermill Stream (Plate 2A). In the Powdermill Stream, 4 baited traps were placed overnight in areas of deeper water more than about 20cm deep. Manual searching of the Powdermill Stream was carried out in June and July. In June a length of stream of about 150m was searched; in July this was extended to about 300m. It was not possible to manually search the Watermill Stream because of the depth of the water and the muddy substrate.

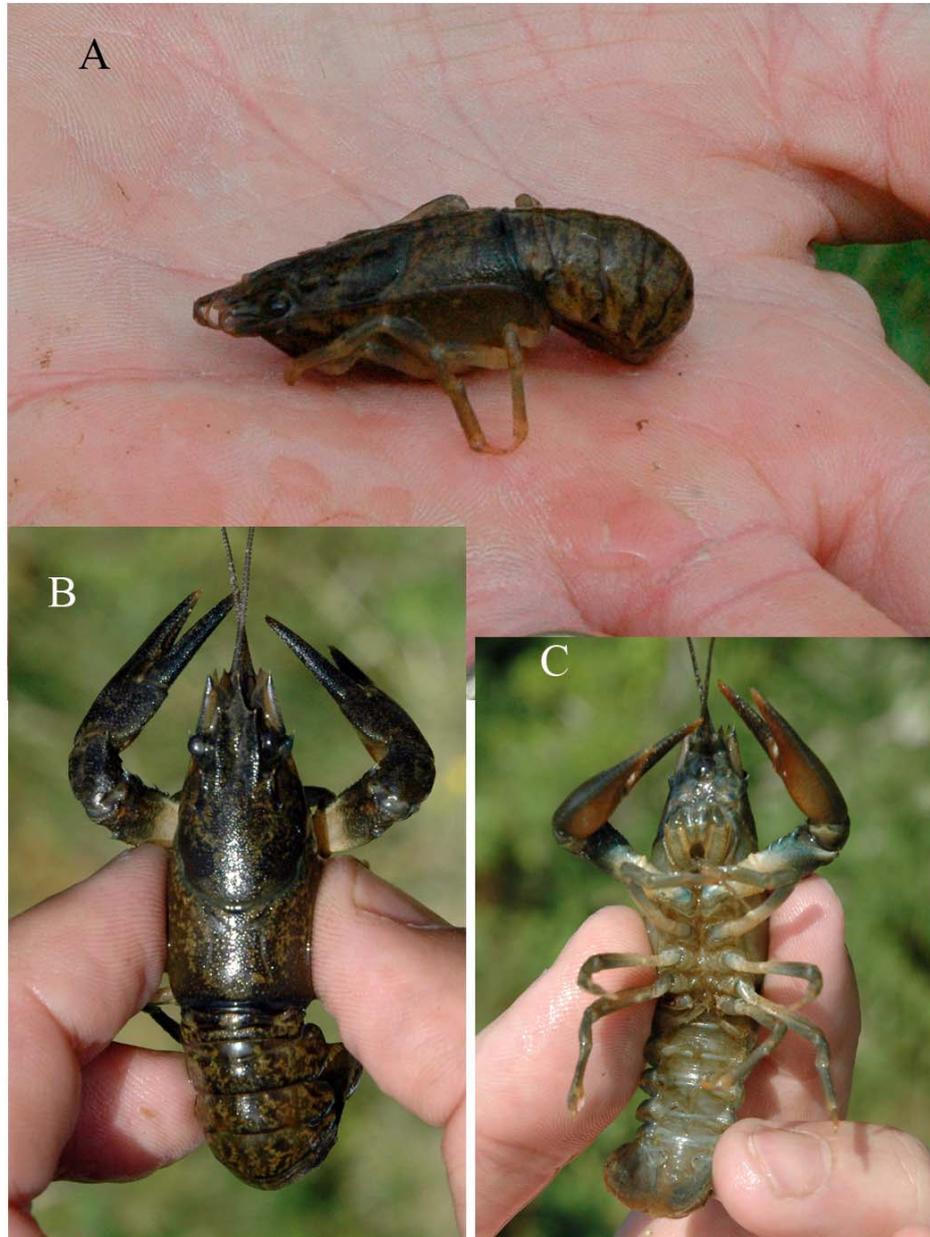
Plate 1 Small crayfish captured from the Powdermill stream. A. The original specimen caught while electric fishing and thought possibly to be a white-clawed crayfish.
B. Dorsal of a small signal crayfish. C. Ventral of signal crayfish

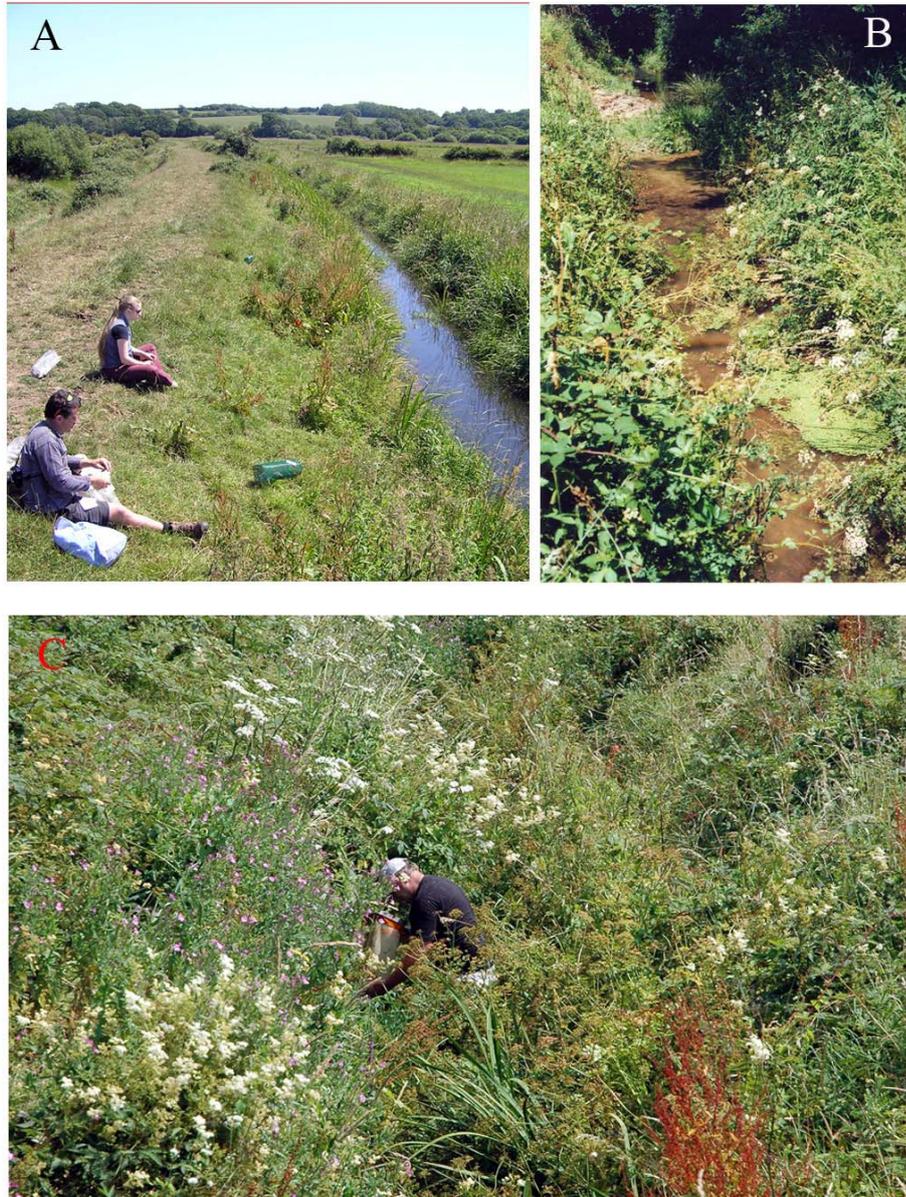
Plate 2 Habitats in the Powdermill and Watermill streams surveyed for crayfish. A, the reach of the Watermill stream that was sampled by trapping. B, the reach of the Powdermill stream holding crayfish. C, sampling in a section of the Powdermill Stream with high vegetation cover which was difficult to search effectively.

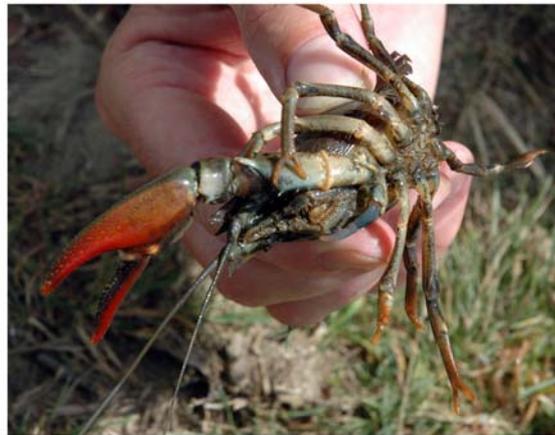
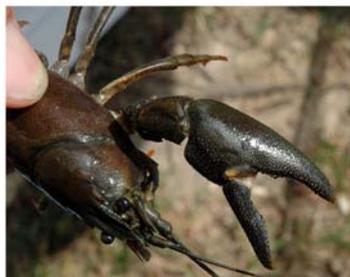
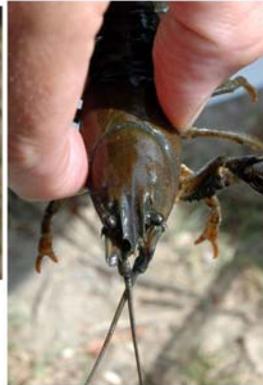
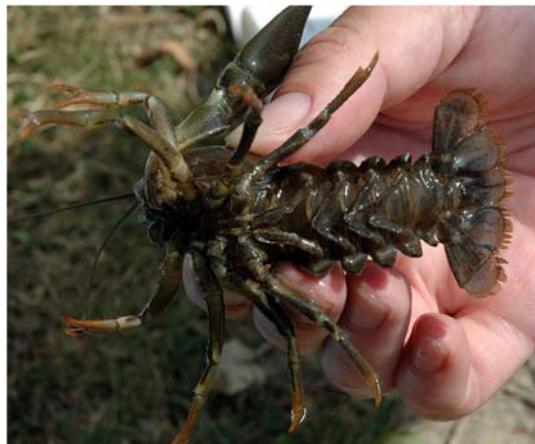
Chelae smooth with a bright red ventral surface.

No spines on shoulders of carapace
Characteristic white patch on dorsal surface of chelae.

Rostrum with smooth parallel borders

Bluish-brown to reddish-brown in colour

Plate 3 Adult Signal Crayfish, *Pacifastacus leniusculus* (Dana) caught in the Powdermill Stream, near Hastings, Kent, showing diagnostic features.

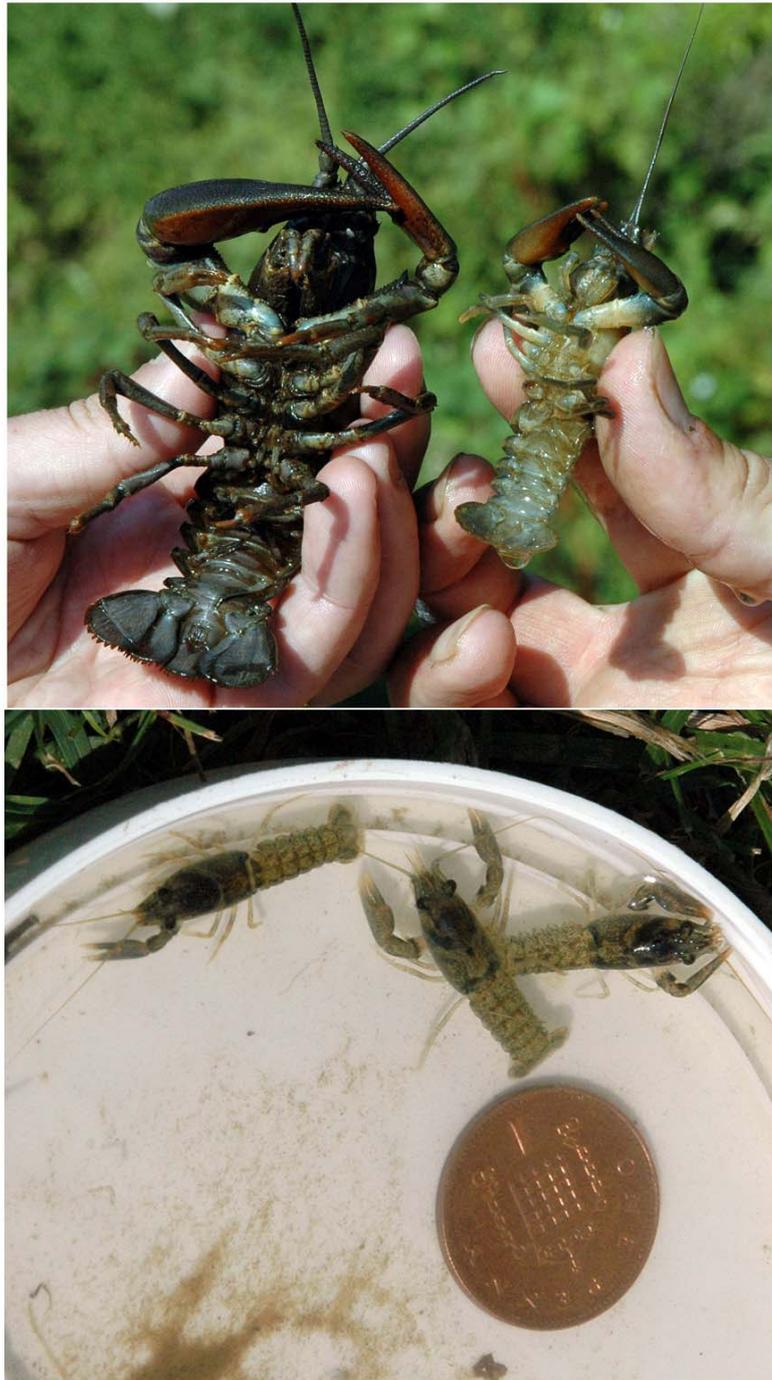
Plate 4 Images of crayfish caught in the Powdermill stream showing the wide size (age) range present.

12-H.3.3 During manual searching in July, 7 Crayfish were captured; a further two large individuals were seen, but evaded capture. All the captures and observations were made in a 50m stretch of the stream close to Adam's Farm, and shown in Plate 2B. This reach of the stream was generally shallow, flowed steadily and offered many rocks and objects for Crayfish to hide under. Further, it was not overgrown with vegetation like many reaches of this stream (see Plate 2C) offering ideal conditions for manual searching. Two large and one small adult (Plates 3 and 4) Signal Crayfish, *Pacifastacus leniusculus*, were caught. Their identification was confirmed by Dr Stephanie Peay, a Crayfish specialist. The wide size range of the capture from large adults to recently born young (Plate 4) indicated that the stream held a healthy population. The small number of individuals captured probably reflects the difficulty of searching much of the stream.
