**Desk-based Assessment
for the
Sovereign Harbour Cycle Network
Phases 2 and 3,
(Ringwood Road to St Anthony's Hill
Roundabout)
Eastbourne, East Sussex
(updated from the original **Desk-
based Assessment for Phase 2A)****

Project No. CBAS0176

October 2012

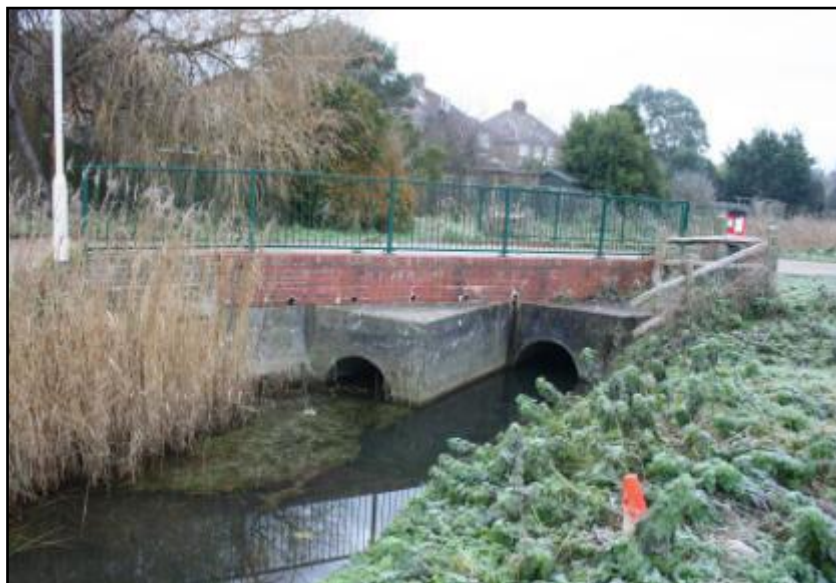
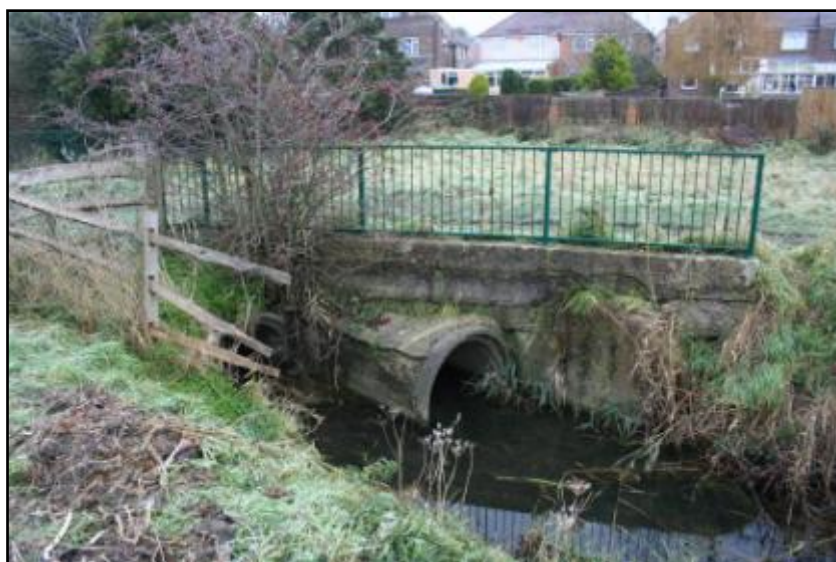
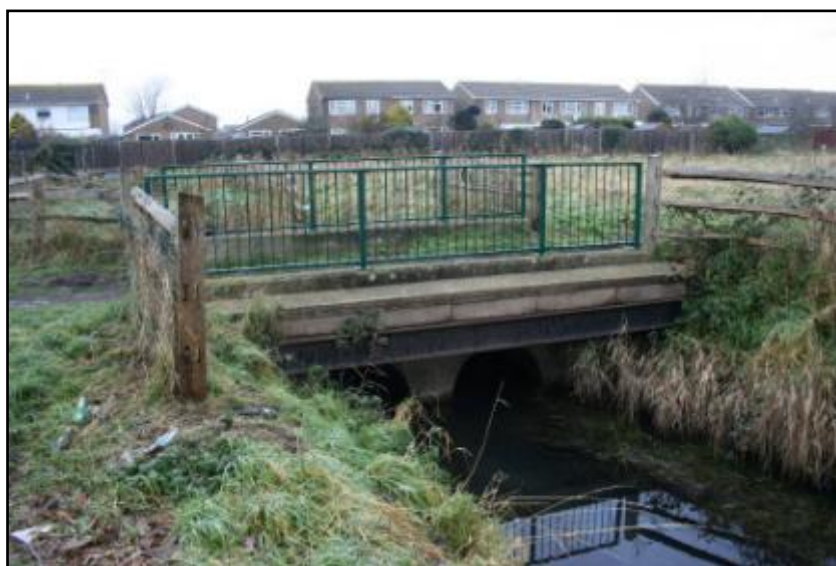
Plate 3: Bridges of Phase 2A cycleway
(Top: Bridge 1; Middle: Bridge 2; Bottom: Bridge 3)

5.1.13 This walkover of the cycleway route has shown that elements of the 19th to 20th century tramway / railway survive, and comprise the three original bridges, and some evidence for the sleepers and ballast forming the trackway. However, it is not clear whether the bridges are the original 19th century bridges or later replacements. No other archaeological features or artefacts were noted during the site visit.

- 7.1.4 It was therefore recommended that a programme of archaeological work be undertaken during the development. An archaeological watching brief should take place to monitor the works, to record surviving evidence for the tramway and other archaeological deposits and features revealed by the works, and a small evaluation excavation in the area of the sleepers adjacent to Bridge 2.

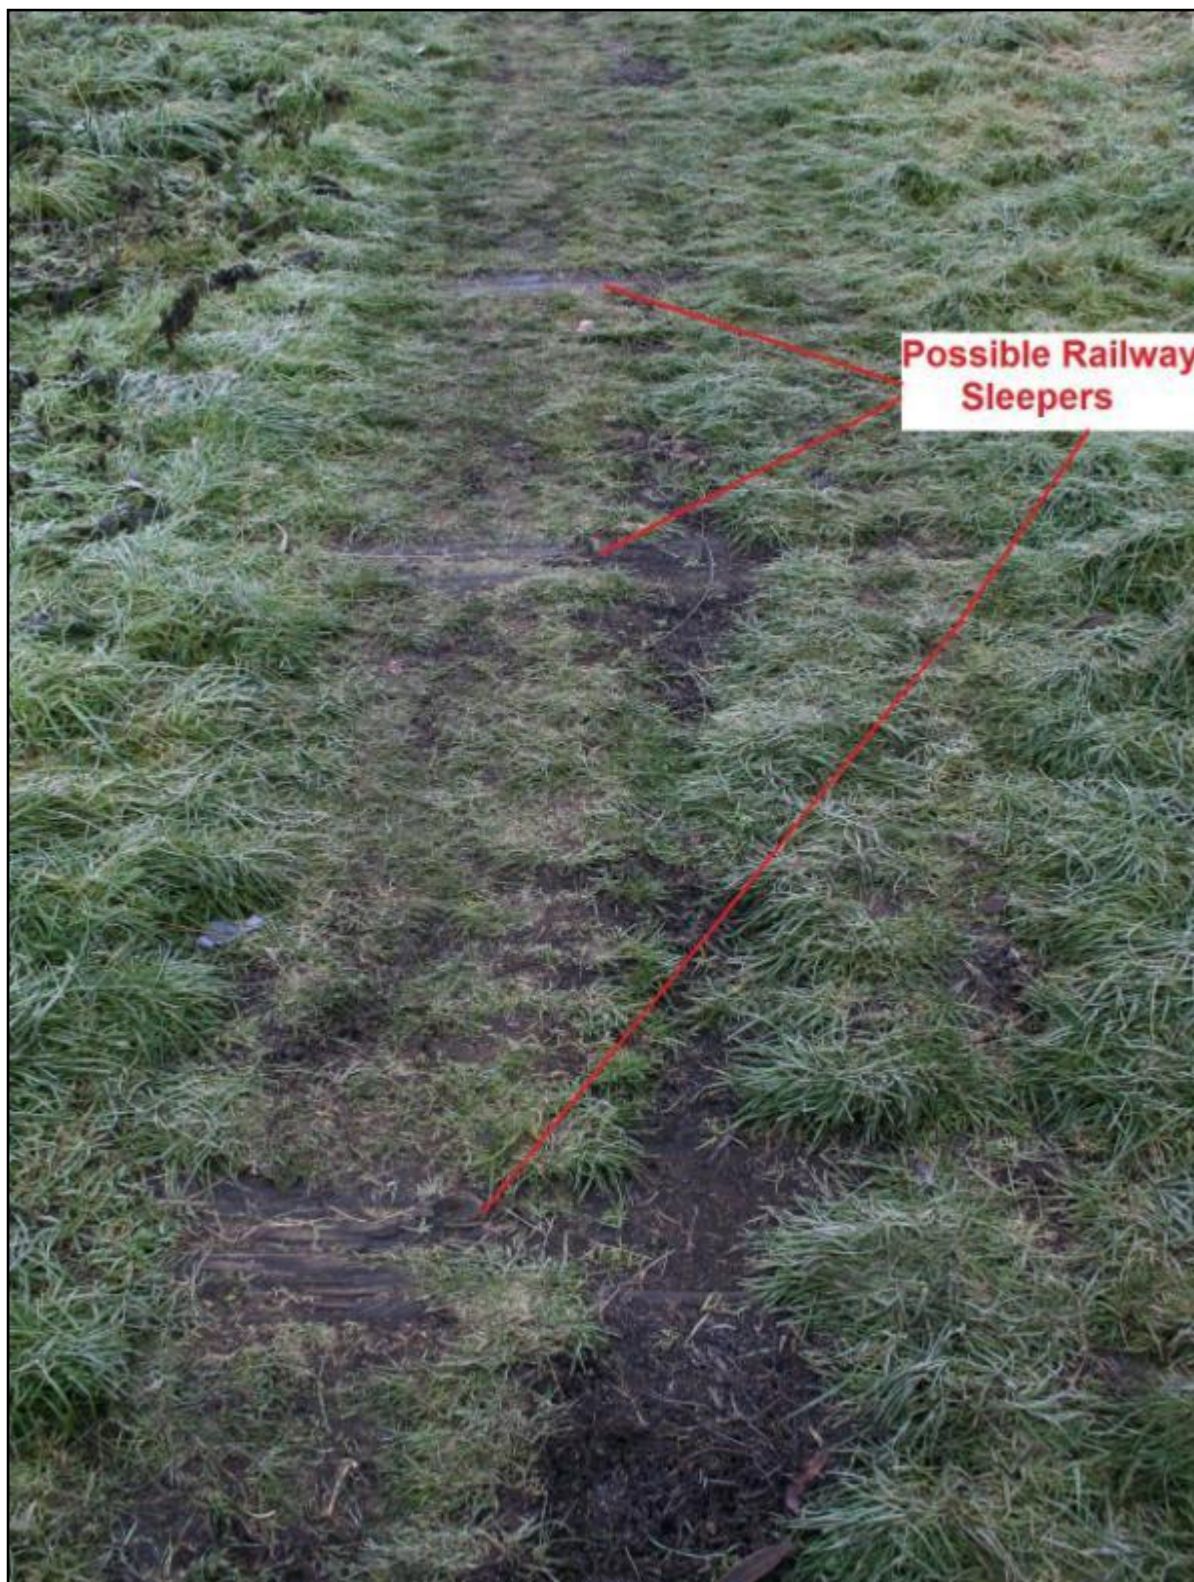
Plate 4: Possible railway sleepers northeast of Bridge 2 of Phase 2A cycleway

- 5.1.5 To the west of Churchdale Road the path is now on the south side of the sewer, and it is partly metalled with gravel / shingle for a short distance. There are also exposed pieces of two worn timbers incorporated into the path which may be surviving sleepers from the tramway. The north side of the sewer is a level strip of grass.

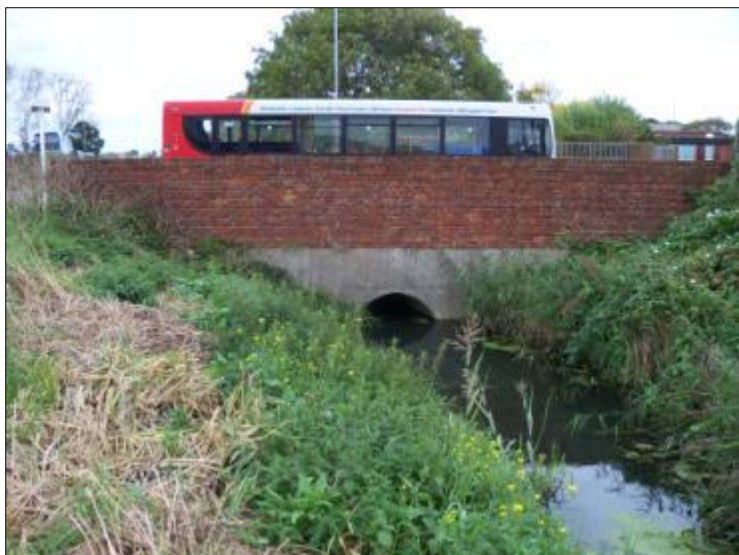
Plate 11: Bridge 6 of Phase 3
cycleway, looking northeast

- 5.2.6 The road bridge (Bridge 6) taking Birch Road across Horsey Sewer appears to have a thick concrete foundation over the concrete culvert, and a red brick superstructure that includes a wall to either side of the bridge (Plate 11). Two culverts flow into the sewer through the northeast face of the bridge.

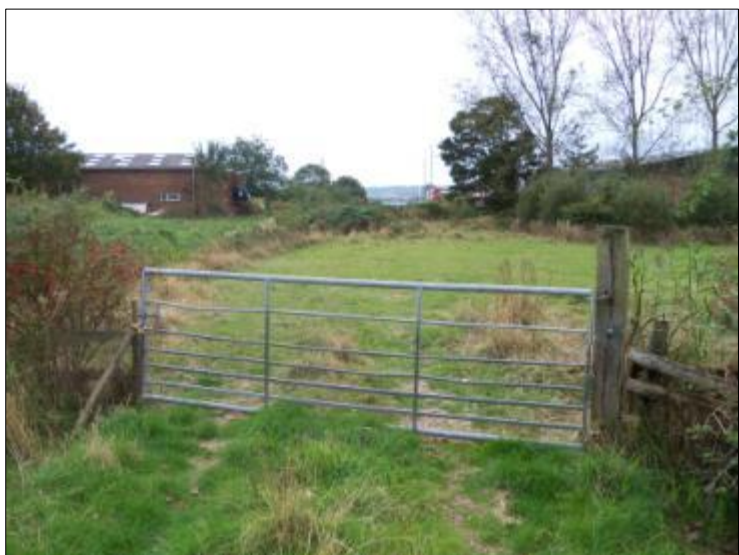
Plate 12: Field 1 (background) and
Causeway 1 (foreground) of Phase 3
cycleway, looking southwest

- 5.2.9 Entry into the next field (Field 2) was through a metal gate and over a causeway (Causeway 1; Plate 12), which was constructed sometime between 1938 and 1960-1961. The drainage ditch was only visible as a line of tall grasses and vegetation, and no structure of the causeway was seen. A culvert probably flowed into the sewer at this point. The surveyed wooden pegs in Field 2 show the cycleway route to run on flat land close to the sewer (Plate 14). A former sluice, with its sluice gate removed, is sited at the top of the field, at the junction between the Horsey Sewer and the Crumble Sewer (Plate 15). This brick and concrete structure has a metal gate blocking vehicle access across it, and has the same green metal railings as Culvert 1. A sluice has been located here since at least 1925-1930. A block of flats (Manton Court) behind the sluice blocks St Anthony's Hill from view. Just to the north of the sluice is a concrete weir-like structure surrounded by metal railings (Plate 16). According to the OS maps, this structure may post-date 1992, although it was preceded by a sluice in 1960-1961. A gas pipeline has been laid beside this possible weir.

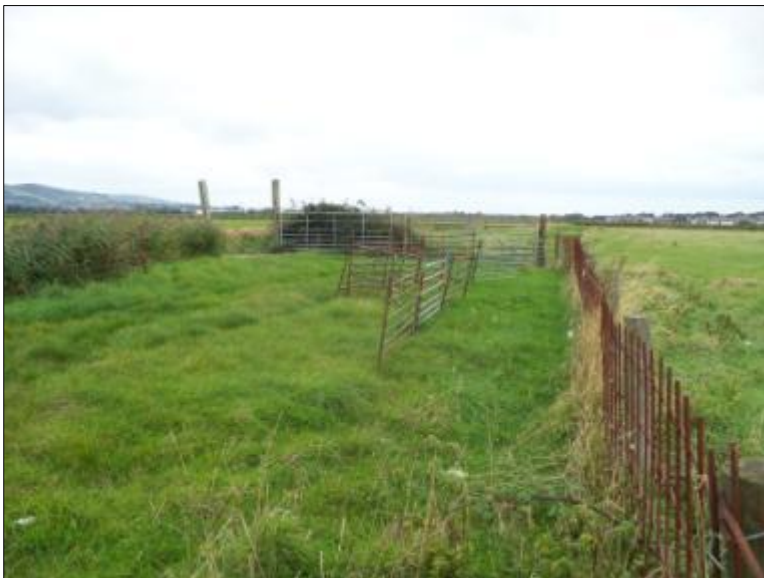
Plate 19: Field 3 of Phase 3
cycleway, looking northwest

- 5.2.12 The bridge leads to a small area of pasture fenced off from the rest of Field 3 with posts and metal frames (Plate 19). From here, movement is restricted to the southeast across a causeway (Causeway 2) and into the next field (Field 4) or northwest through a metal gate into the field beyond. The metal fence panels that stand within the enclosure reveal that it is used to separate livestock, probably sheep. The enclosure was in place by 1925-1930 although it resembles part of a larger enclosure in use by 1910, which is not traceable on the ground surface. The cycleway is to run northeast through the fencing of this enclosure and will cross the drainage ditch to the northeast of Causeway 2. This causeway (Plate 20) was built sometime between 1795 and 1875. Its structure is not discernible, as the ditch to either side of it is overgrown. No wooden pegs mark the route of the cycleway beyond the causeway.

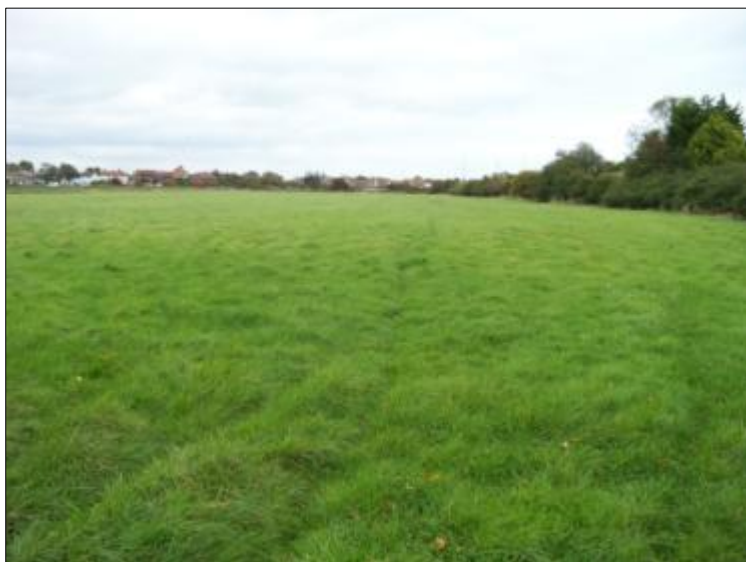
Plate 21: Field 4 of Phase 3 cycleway, looking northeast

- 5.2.13 Field 4 has a path / animal track that runs largely in line with the Phase 3 cycleway route, from Causeway 2 to Causeway 3 at the other end of the field (Plate 21). From this field, St Anthony's Hill is observed as a concentration of housing which appears to stand not that much higher than the surrounding Levels (Plate 22). The drainage ditch between Field 4 and the last field (Field 5) is overgrown and only noticeable as a line of vegetation. There is therefore no visible structure to Causeway 3, although vehicle tracks have exposed it as having a gravel hardstanding below the grass. A wooden post stands erect beside the causeway and reveals that a gate would once have been present. This causeway has been here since at least 1795.

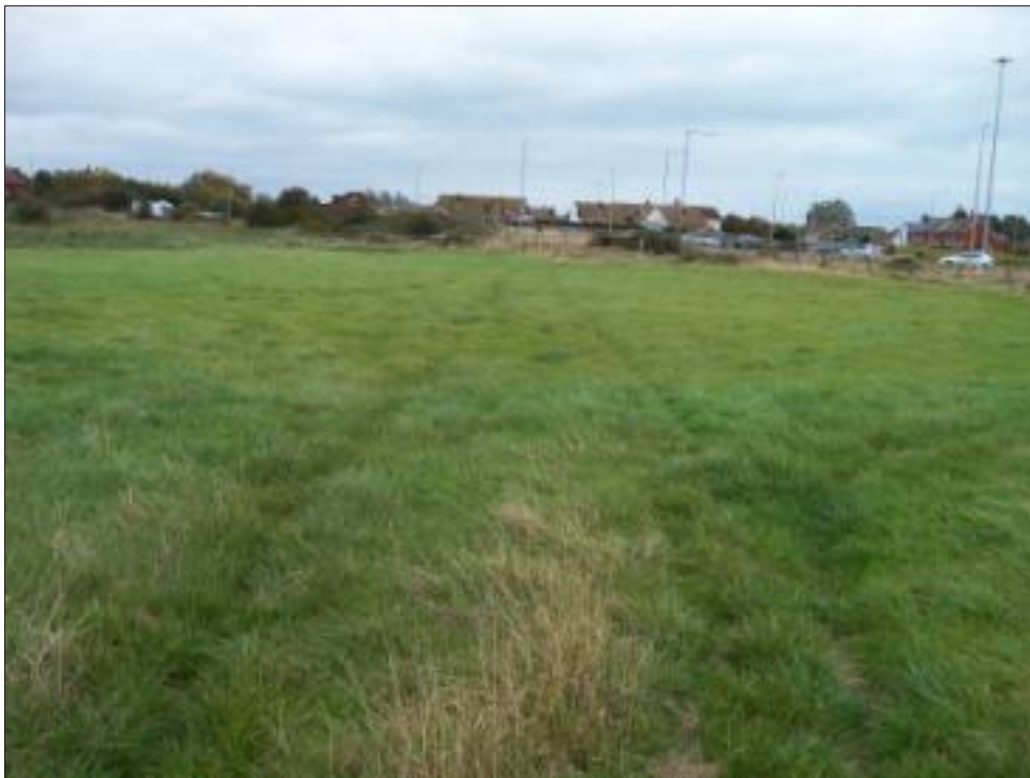
Plate 23: Field 5 of Phase 3 cycleway, looking northeast

- 5.2.14 In Field 5, a patch of tarmac within the grass was seen beside Causeway 3. Tracks run from the causeway up to the metal gate beside the roundabout (Plate 23). Fragments of brickwork faced with thick concrete have been dumped to either side of this gate (Plate 24). They are likely to represent the demolition rubble of the one or two buildings, built here between 1962 and 1975 and pulled down by 1992. There are three old concrete posts beside the rubble, which may represent a former gate and fenceline.
