British Gypsum Robertsbridge

Truck Service Depot and Parking Area Flood Risk Assessment and Drainage Strategy

15294
June 2020
Rev C 20 July 2020

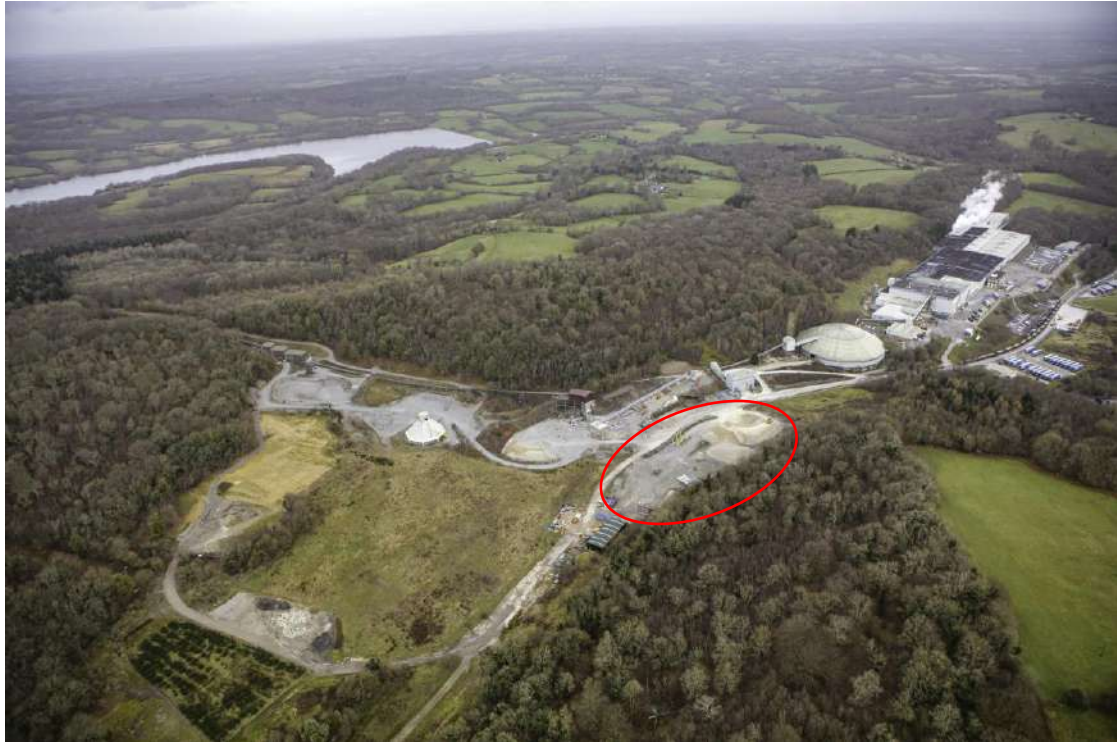
Aerial photograph of the British Gypsum site (February 2020).

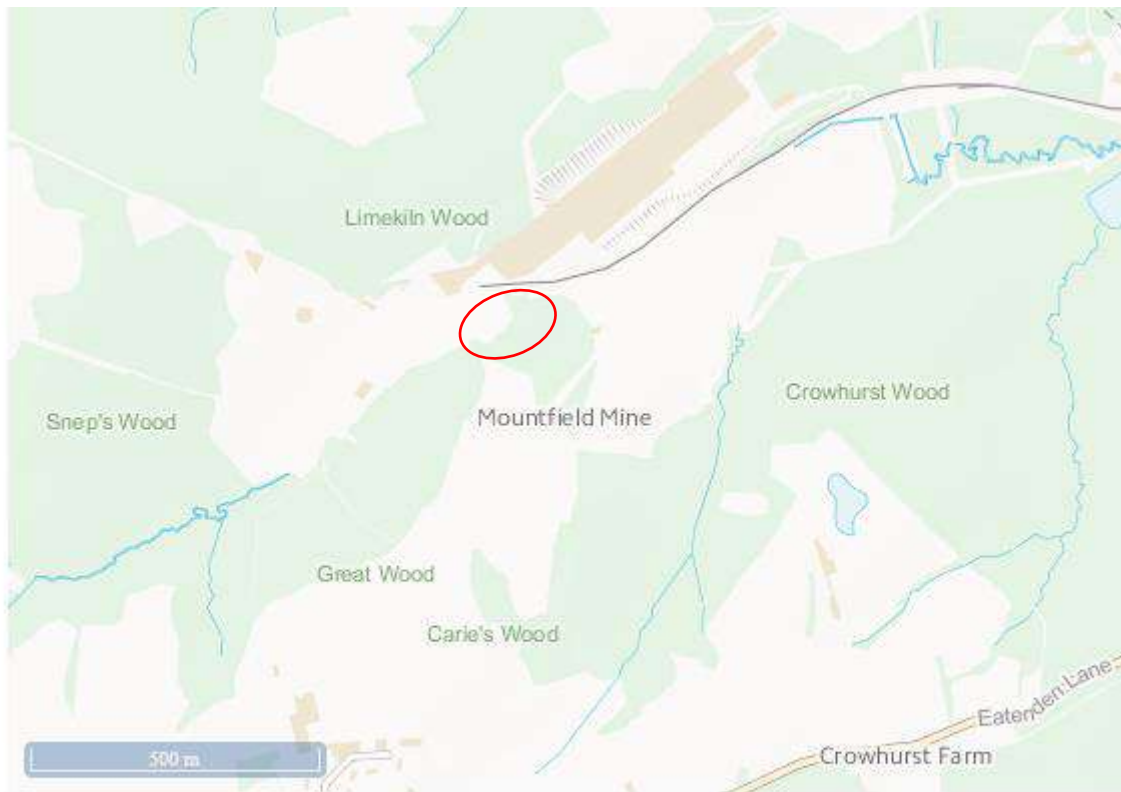
Extent of flooding from rivers or the sea

Extract of river or sea flooding map from Gov.uk website

- 5.1 During the preparation of this assessment the Gov.UK website was consulted to obtain details of any potential flooding or drainage impacts on the site.
- 5.2 The extract of the interactive river or sea flooding map below shows that the site itself is considered to be at very low risk of river and sea flooding.

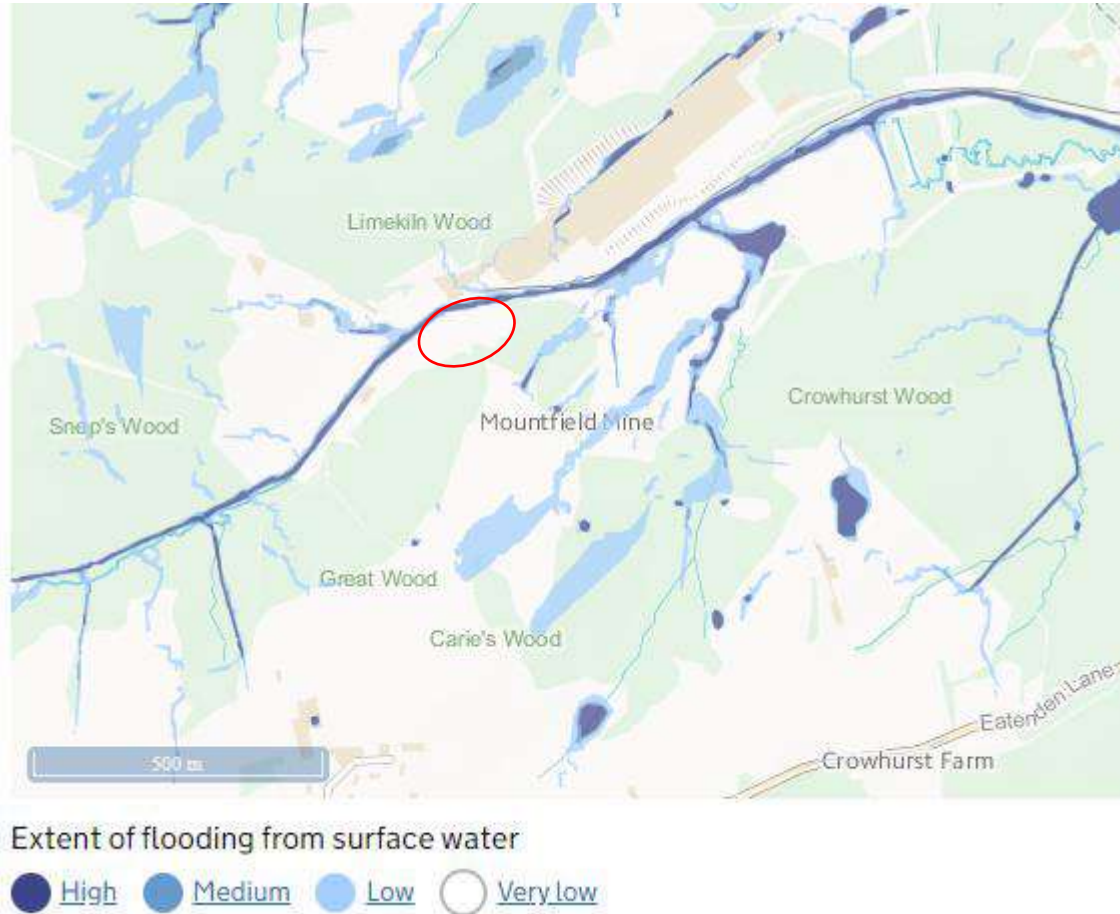
Extract of surface water flooding map from Gov.uk website

5.3 The extract of the interactive surface water flooding map below shows that the site itself is considered to generally be at very low risk of surface water flooding, although the area directly along the river itself is at high risk of flooding. Typically, land around the site is considered to be at very low risk.

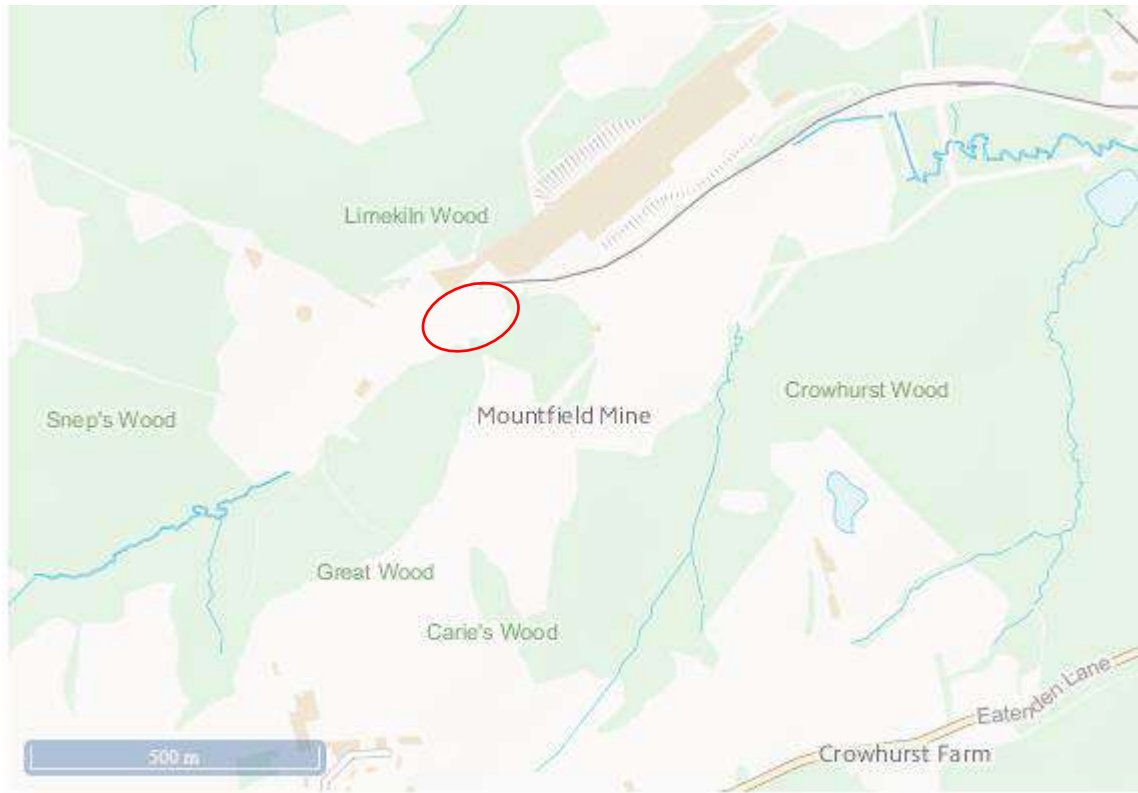
Extent of flooding from reservoirs

5.4 An interactive reservoir flood extents map is also available on the Gov.UK website. This shows the site to lie outside of the maximum extent of flooding.

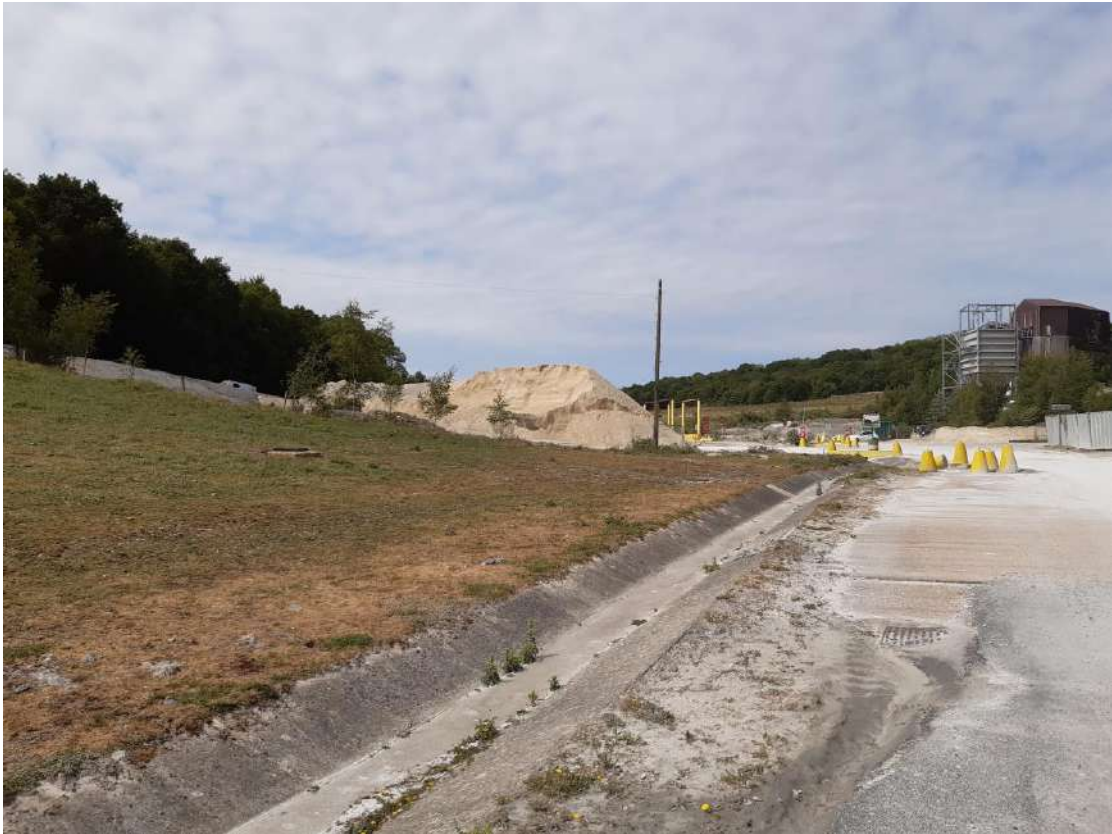
Photograph 1 – Existing channel drain beside access road

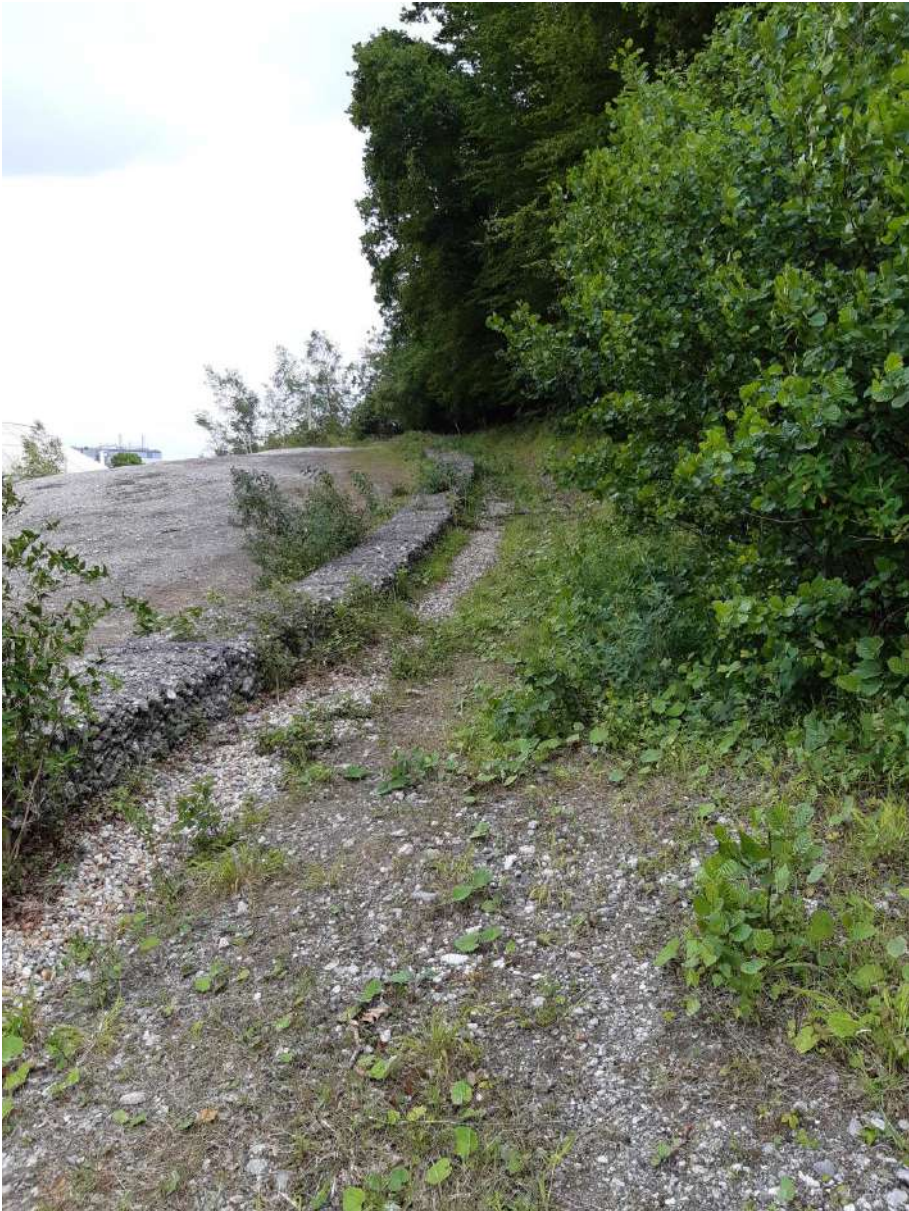
Photograph 3 – Gabion wall and French drain, south side of Old Works area

- 7.4 There is a French drain behind the gabion wall on the south side of Old Works area, and the gabion position is shown on Figure 2.
- 7.5 There are currently two silt traps, one adjacent to outfall W4 collecting flow from the open concrete lined ditch and the other adjacent to the western side of the Train Unloading Pad (TUP) area collecting flow from the south side of the access road French drain. It is recommended that both of these remain in operation.

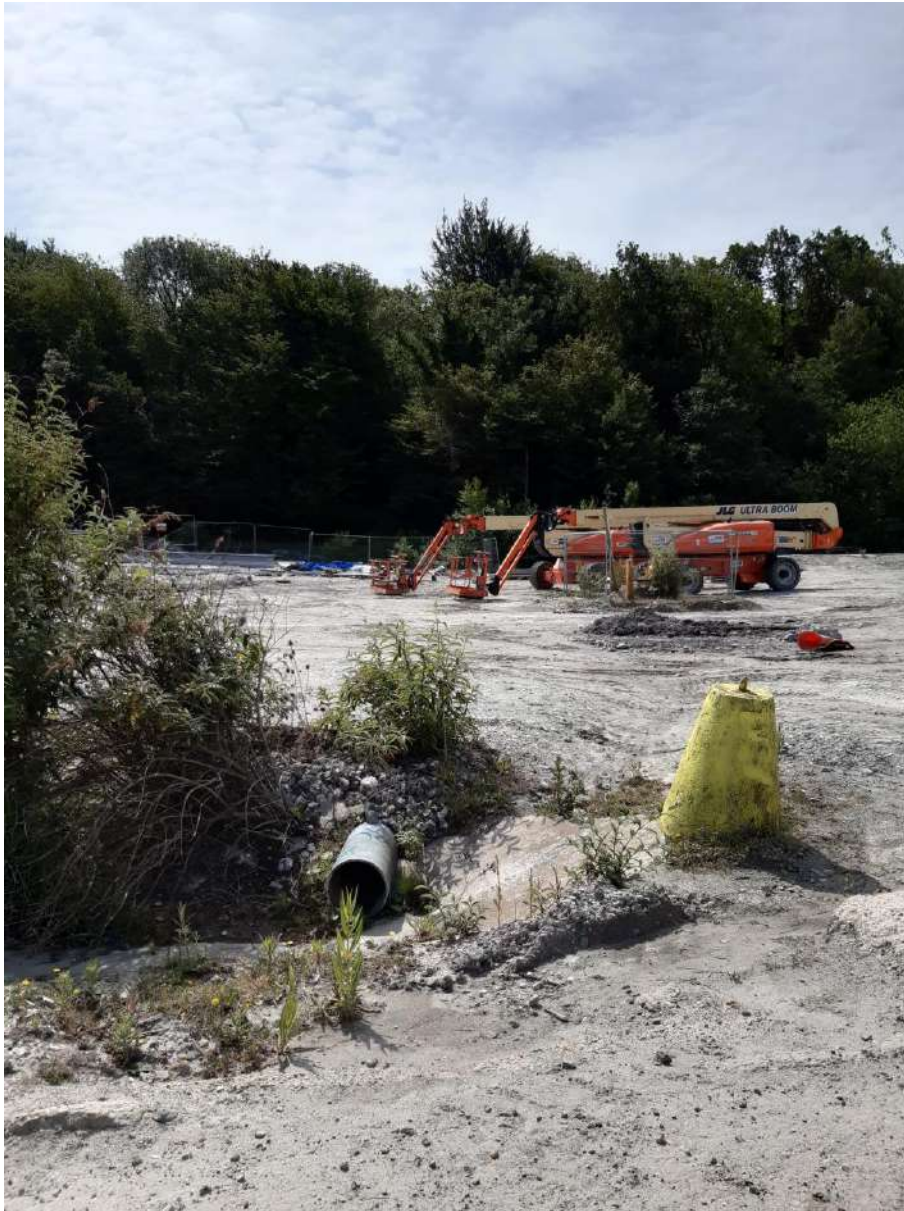
Photograph 4 – Drainage outfall from filter drain behind south side gabion wall
