**MOUNTFIELD FIRST TIME SEWERAGE SCHEME,
EAST SUSSEX**

WHITE-CLAWED CRAYFISH HABITAT ASSESSMENT

A Report to The Clancy Group Plc

Report Number: RT-MME-115661-04

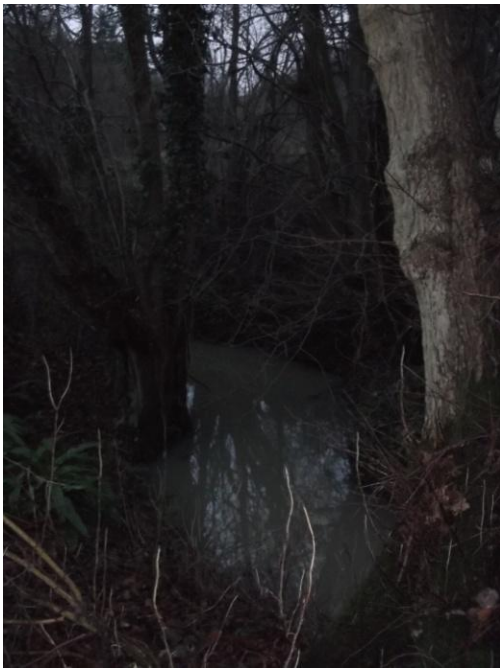
Plate 3.1: River Line

The section of River Line surveyed was approximately 400m in length. This section of the river was heavily shaded with steep bare earth banks scattered with leaf litter. The river was approximately 1-1.5 m wide and 400mm deep (Plate 3.1 and 3.2). There were no boulders, stones or other similar features that white-clawed crayfish could utilise for refuge. The substrate of the river was mainly silt with accumulation of detritus, although WCC will use areas of deep detritus for feeding, the silt and lack of refuge features such as boulders, tree roots etc. is considered unsuitable habitat for WCC. At the time of the survey water was very murky indicating a poor water quality. All this combined makes this section of the river suboptimal for white-clawed crayfish.

The deep silt and lack of suitable refuge areas (i.e. rocks/large stones or tree roots) makes the section of River Line being affected by the proposed development unsuitable for WCC. This combined with lack of records provided by the desk study suggest that WCC are not currently present within the development area. Therefore no further surveys are required and works can proceed as planned with regards to WCC.
